PRELIMINARY INVESTIGATION
REPORT ON THE
SINKING OF
M/V AL SALAM BOCCACCIO 98

August 17, 2006

Panama Maritime Authority
General Directorate of Merchant Marine
Casualty Investigation Branch

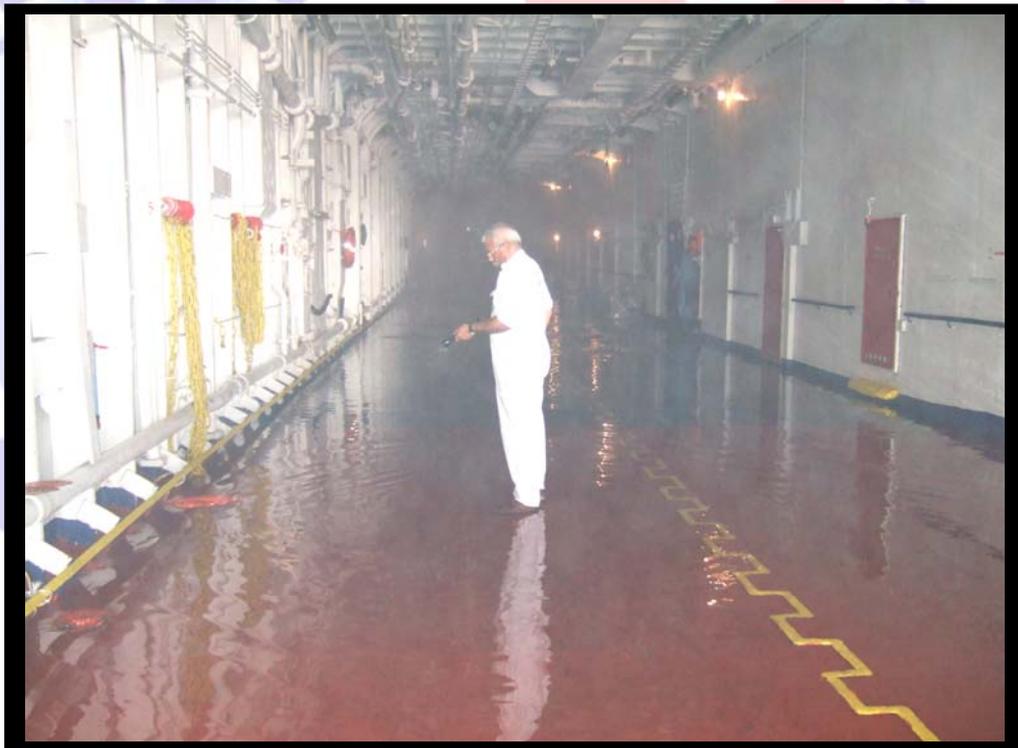
Figure 5

Scuppers testing with the sprinklers

Note: As per the evaluation carried out on board one sister ship, in ideal conditions, it is clear that in a short period of time (10 minutes in this case), the accumulated amount of water can rapidly increase in the car deck.

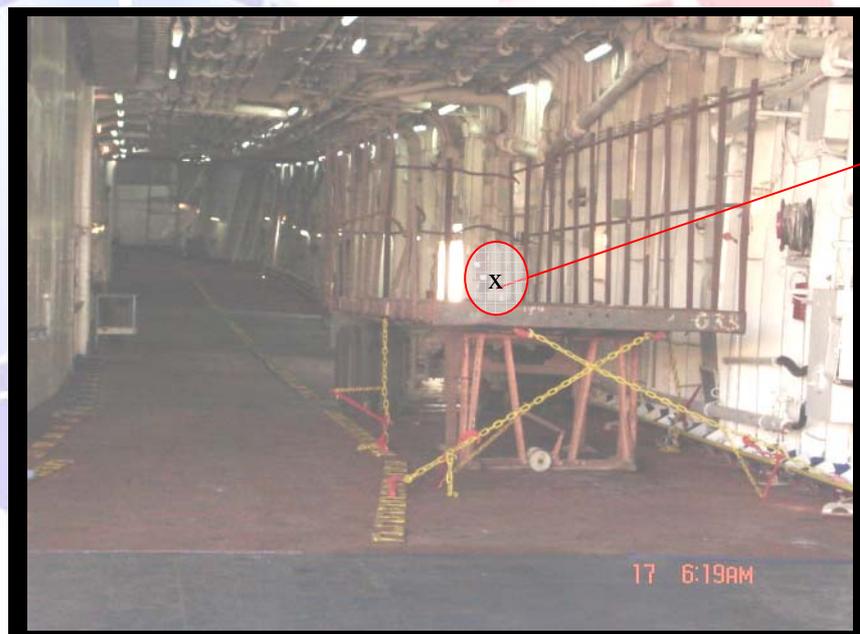
Figure 6

Picture of a trailer for luggage and cargo lashing, looking from starboard aft to fwd.

**Normal place
for the
stowage of
luggage.**

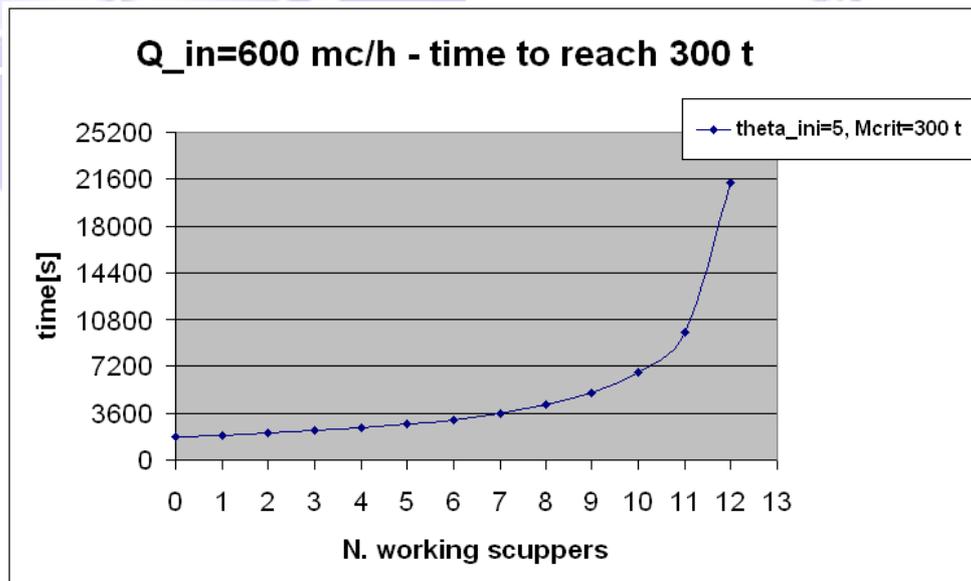
Figure B 3

The results obtained with a constant input flow rate of 600 [m³/h] and an initial angle of heel of almost 5 degrees are shown in Figure B3 below.

The resulting time for 13 active scuppers has not been graphed because it can be considered as infinite.

These results show that even with 0 active scuppers almost half an hour is available before capsizing occurs; on the other hand this time frame does not increase at a high rate with the increment of the number of scuppers (e.g. with 7 active scuppers 1 hour is available). This behaviour depends from the fact that the initial condition (angle of heel equal to 5 degrees) impairs from the beginning the flow rate discharged from the scuppers with its low value of H. In any case with all the 13 scuppers active, the simulation predicts that the system does not tend to accumulate water.
