SAFETY INVESTIGATION REPORT

REPORT NO.: 10/2012

August 2012

MV KAROLINE **Fatality of a crew member** **At Aliaga Port, Turkey** **23 August 2011**

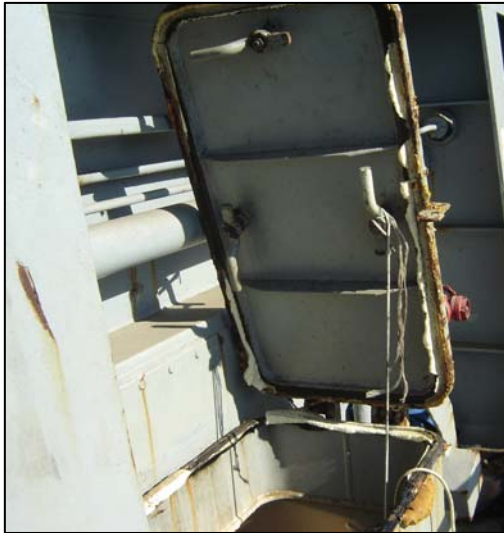
It was stated that at about 1525, the first AB was looking on the main deck and observed that the starboard access shaft cover to the cargo hold was open (Figure 1). He thought that this was somewhat peculiar given that this particular access was not normally used by the crew.

Figure 1: Starboard cargo hold access shaft from the main deck

The access cover to the shaft from the main deck (Figure 1) had a three-dog closing arrangement, which secured the cover against rubber packing. This created a weather tight seal. Two of the dog handles could be locked by padlocks. The cover also had padlock eyes welded on the side.

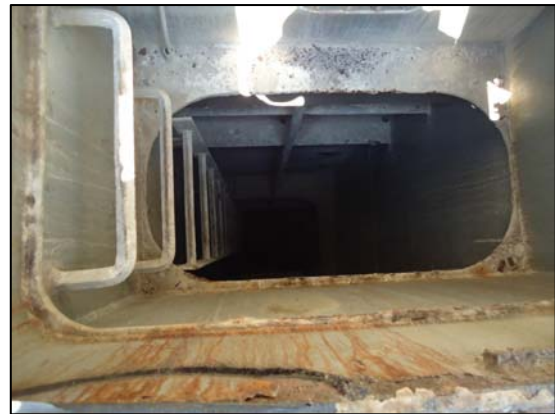
In the meantime, the AB attempted to reach his colleague through the same access and down the ladder (Figure 2).

Figure 2: Starboard cargo hold access ladder from the main deck

The AB stated that after going down four or five rungs, he could go down no further due to the intense odour of gas, which irritated his nasal mucosa. He therefore returned to the main deck, brought a BA set from the accommodation, and went down again inside the cargo hold access shaft.

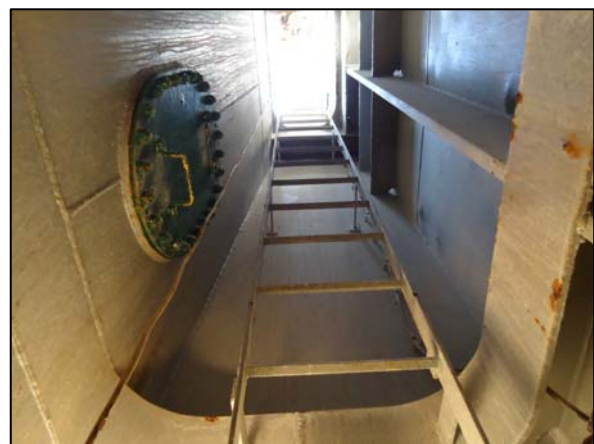
Upon reaching the crew member at the bottom of the access shaft (Figure 3), the AB noticed that his colleague was unconscious with his left foot resting on the lower rung.

Figure 3: Bottom-up view of the starboard cargo hold access from the main deck

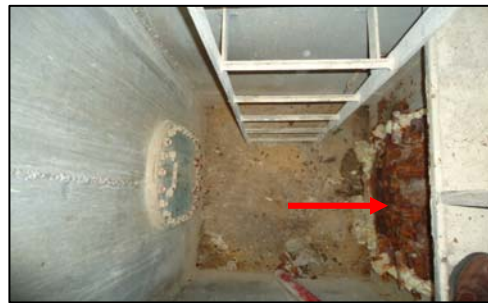
The death of the crew member occurred inside the starboard access shaft to the vessel’s cargo hold, situated at the starboard passageway, several metres forward of amidships. At the bottom of the access shaft was an access hole (Figures 4 and 5), which was found sealed when the MSIU investigators were on board (*vide* Footnote 3).

Figure 4: Ladder leading down the space. The access hole leading to the cargo hold is on the right-hand side

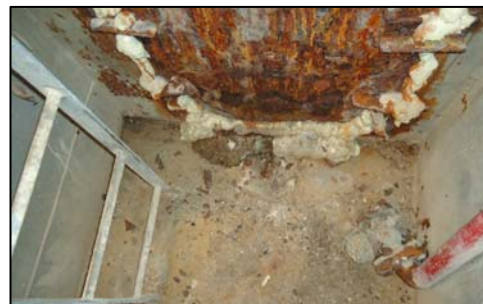
Figure 5: Access hole leading to the cargo hold sealed with expanding foam

In fact, both had been hermetically sealed with expanding foam and this was known to all crew members. Interviewed crew members confirmed that they had not received any specific instructions on being prohibited from using the port and starboard access hatches. However, they were all aware of the potential dangers related to accessing enclosed and confined spaces.

The access hole referred to in (c) was found blocked with a steel plate (Figure 5), kept in place by welded steel plates, although not hermetically tight since expanding foam had to be applied all around. The foam was not uniform and its water tightness (or lack of it) could not be ascertained. If not tight, it would have been a plausible path for gas / air exchange from one space to another.

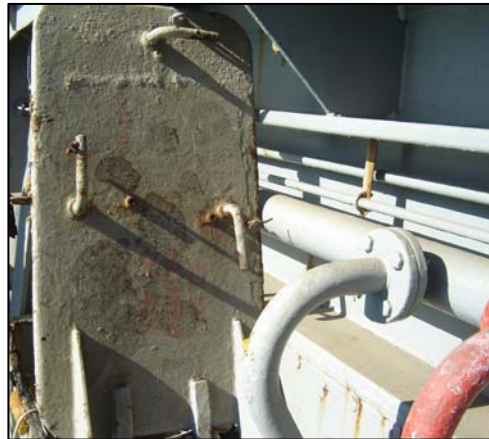
It transpired that no padlock was used to secure the cover. Moreover, there were no warning signs posted prior to the entry of the starboard access trunk to indicate that either entry was prohibited or to be carried out only after an enclosed space entry permit was issued⁴ (Figure 6).

Figure 6: “Restricted Area / Zone” signs not painted on the access cover

In fact, the precautionary warnings were painted on the access shaft covers after the fatal accident.

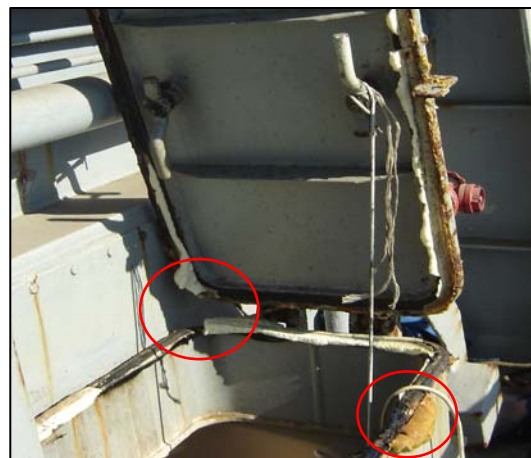
However, notwithstanding the missing padlock/s, it was evident that the access from the main deck was sealed with expanding foam (Figure 7).

Figure 7: (Cured) expanding foam

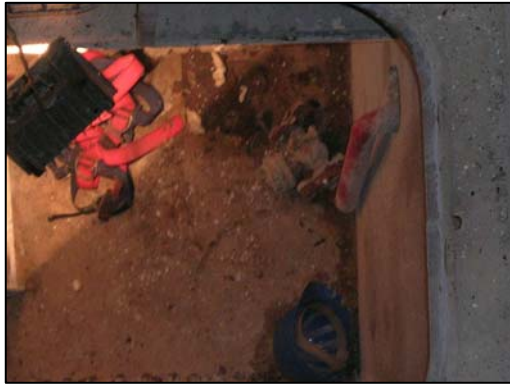
Figure 8: Condition of the access shaft several hours after the accident

Figure 8 is a photograph which was taken on the day of the accident from inside the access shaft. The local authorities found a safety harness inside, which was presumably intended to be used after the accident. A blue safety helmet, also found inside the access shaft, was believed to belong to the AB.

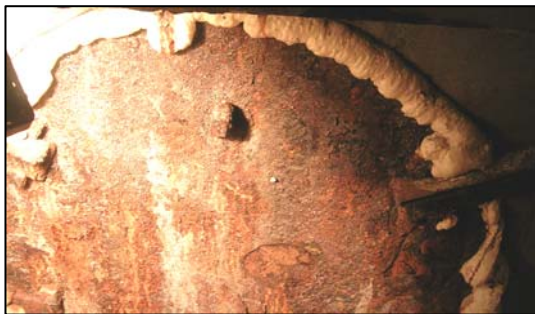
Figure 9: Steel plate and expanding foam blocking the access to the cargo hold

The photographs represented as figures 9 and 10 also show that the steel plate between the access shaft and the cargo hold was in place. This increased the probability that the accident happened in an oxygen-depleted space.

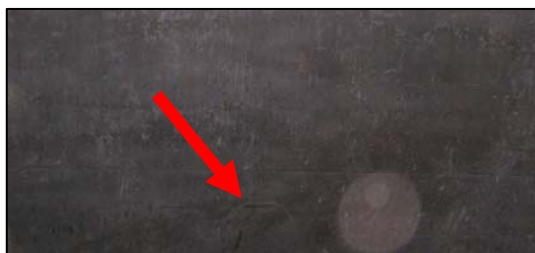
Figure 10: Steel plate from the inside of the cargo hold

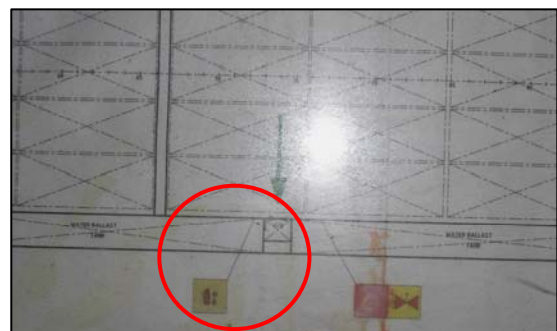
Whilst the vessel's fire plan indicated that one portable fire extinguisher was located in the access shaft (Figure 11), several photos of the access shaft indicated a strap to secure a portable fire extinguisher (Figure 12).

Figure 11: Part of the vessel's fire plan showing the portable fire extinguisher located in the access shaft

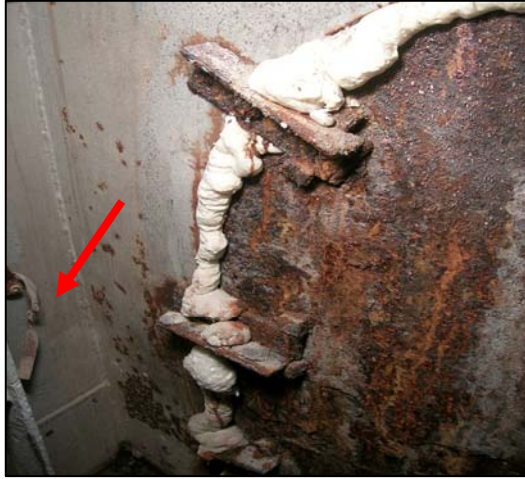
Figure 12: Portable fire extinguisher strap located in the access shaft where the accident happened

No portable fire extinguishers were found in the access shaft when the safety investigators boarded the ships days after the accident. In this respect, it cannot be confirmed whether or not the fire plan was accurate at the time of the accident.
