**REPUBLIC OF CYPRUS  
MARINE ACCIDENT AND INCIDENT  
INVESTIGATION COMMITTEE**

**Investigation Report No: 174A/2016 (Simplified)**

**Serious Marine Casualty**

**High Speed Craft “Mykonos Jet” under tow sinking in  
the East China Sea on the 29th of October 2016**

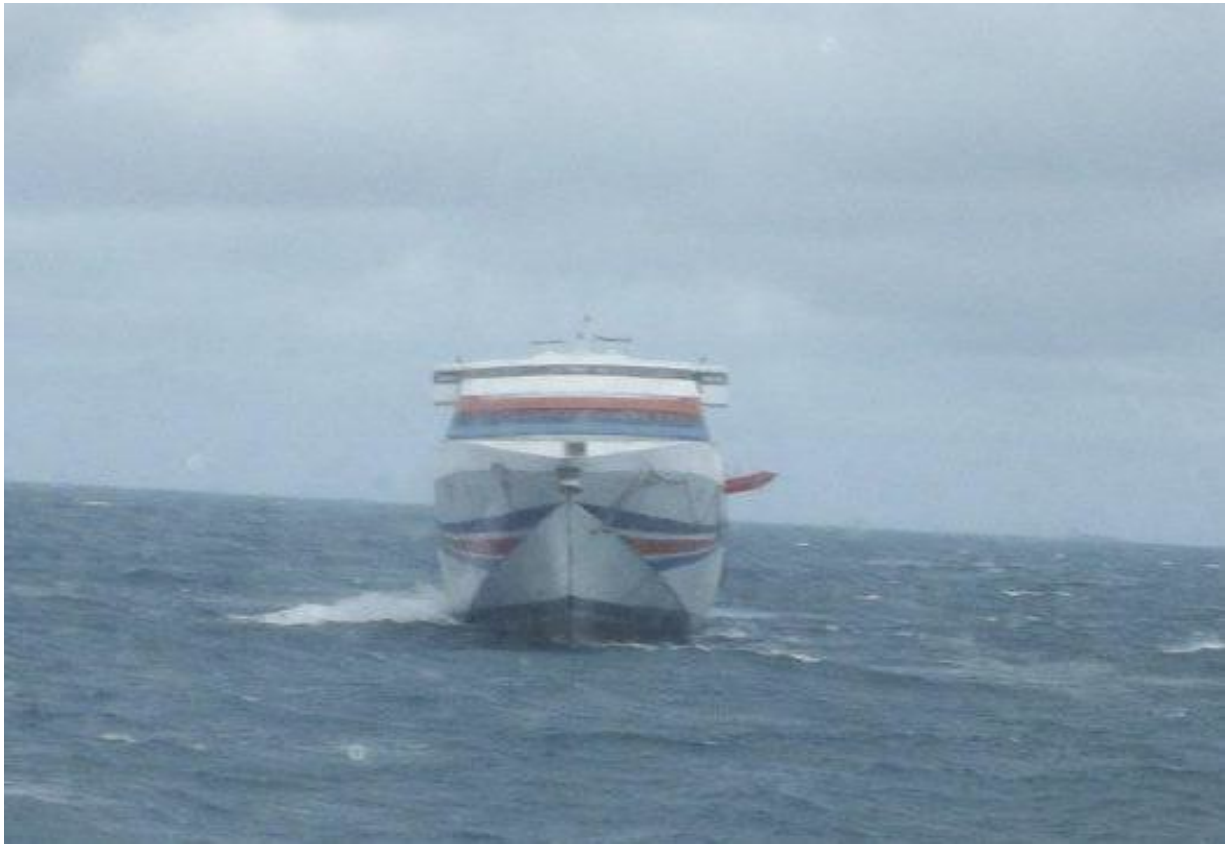
**HSC “Mykonos Jet” under tow.**

**Photo taken after departure from South Korea - Date: Unverified (27th or 28th October)**

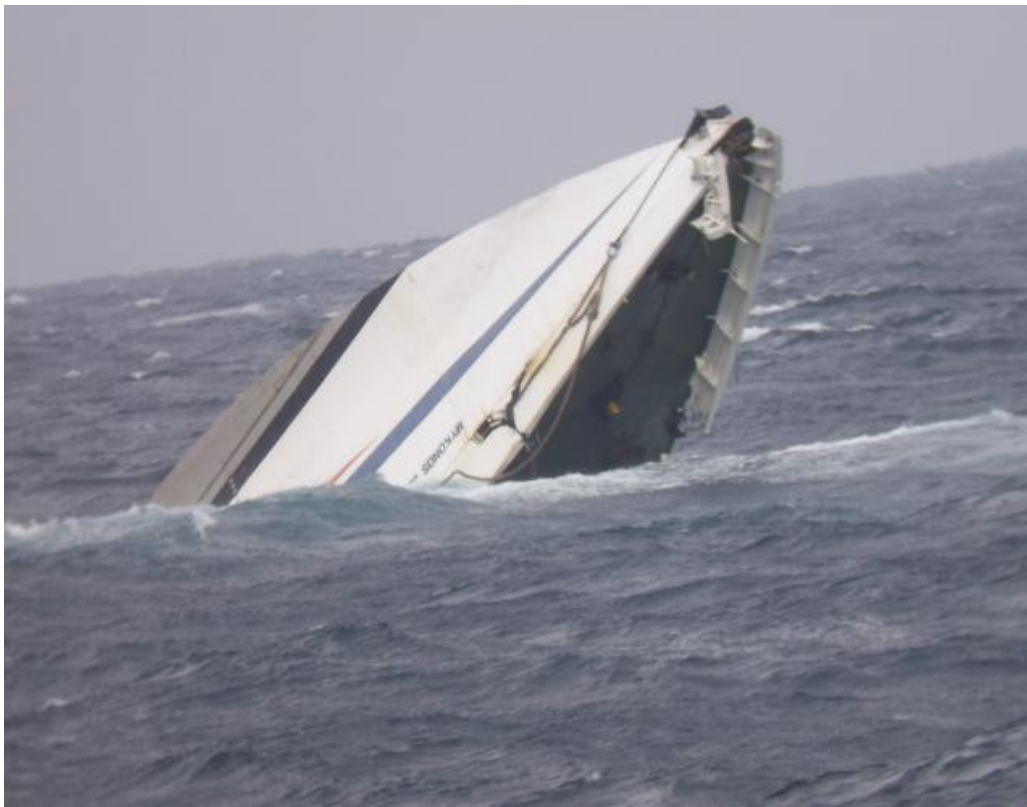
14. On 29/10/16, at approximately 01:30 Hours LT, the HSC “Mykonos Jet”, sank in position Lat. 29°50' 96 N - Long 123°36' 49 E in the East China Sea. Her stern touched the sea bottom and about 15m of the fore part, were extending over the sea level.

**On the 29th of October 2016, at 01:30 Hours LT, the HSC “Mykonos Jet” sank in position Lat. 29° 50'96 N - Long 123 ° 36'49 E, in the East China Sea**

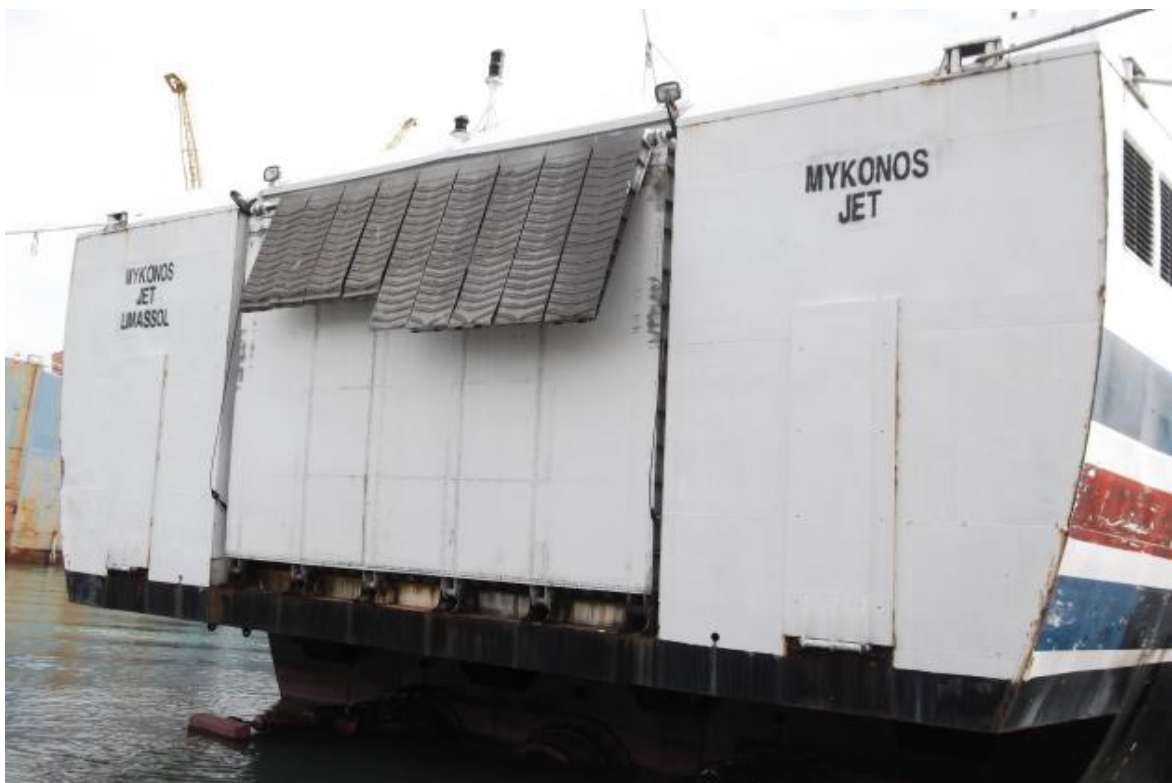
**Stern view of HSC “Mykonos Jet”, showing: Port ramp door for passengers, Centre ramp door for vehicles, Starboard ramp door for passengers  
Class Assessment (for admission to Class): Port of survey MOKPO-South Korea. Date of survey 25/10/2016: - Outside shell plate with doors and steering device have been inspected visually and found in good condition**

Although pre-tow fitness surveys were duly conducted prior to the tow’s departure, the ferry was fitted with ramp doors. These doors were held together in place with “hydraulic” locks as a fail-safe. However, it should be noted that the ferry was being towed in dead-ship condition. As such a hydraulic leak in the system may cause “creeping” of the ramp doors allowing water to enter the engine room spaces slowly until the stern spaces were below the water.

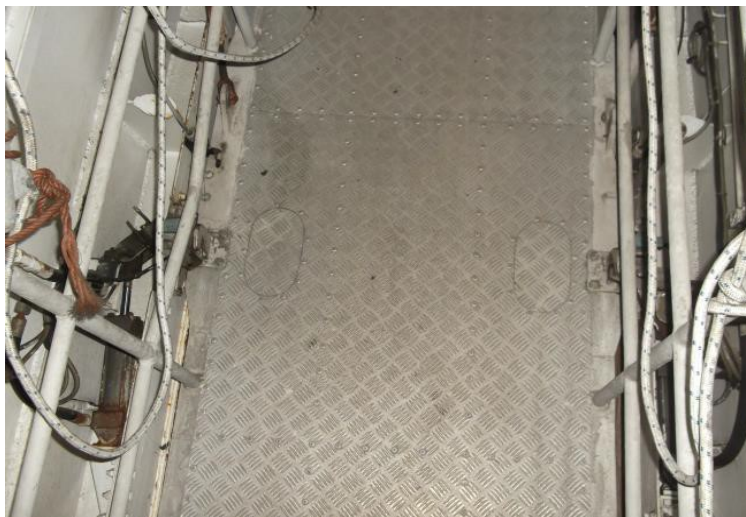
**Passengers ramp door**

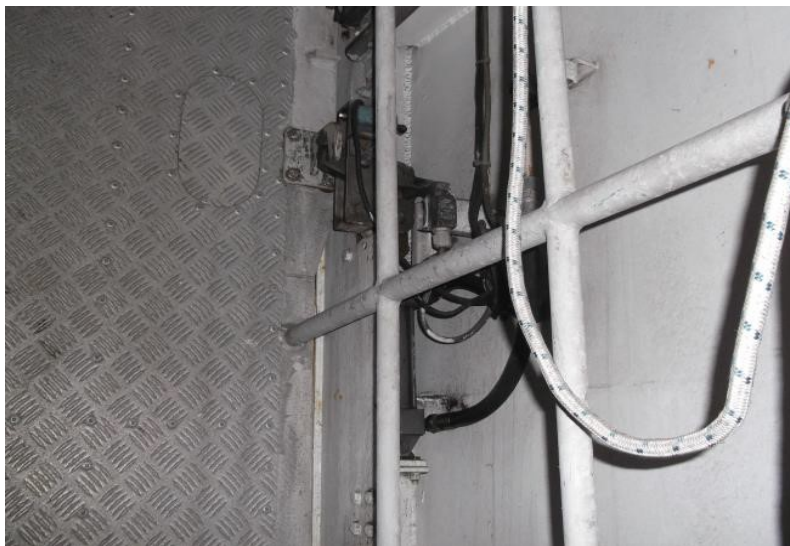
**Close-up view of the hydraulic locking (fail safe) arrangement**

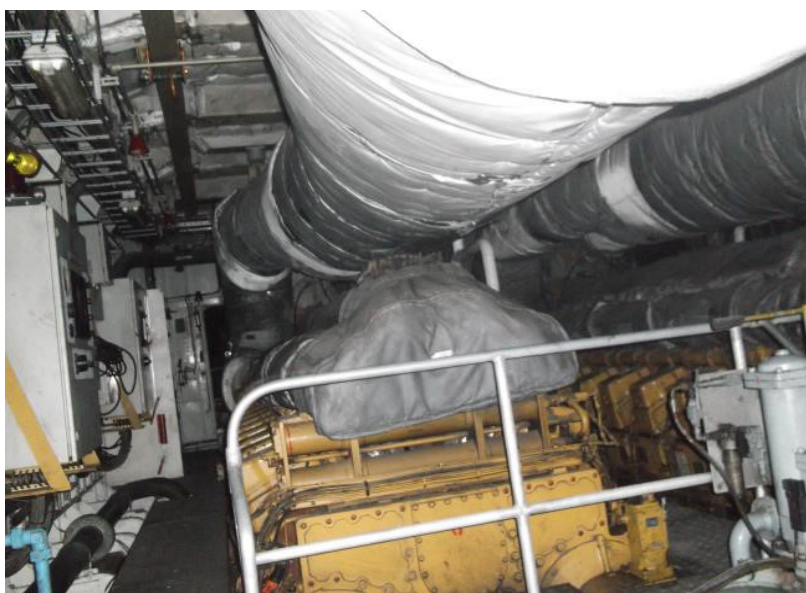
**Inside engine room – (was reported in dry condition)**

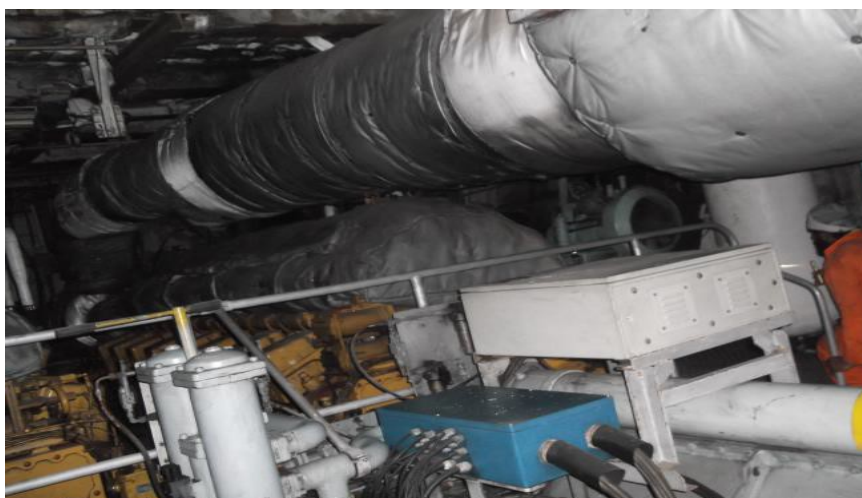
**Inside engine room – (was reported in dry condition)**

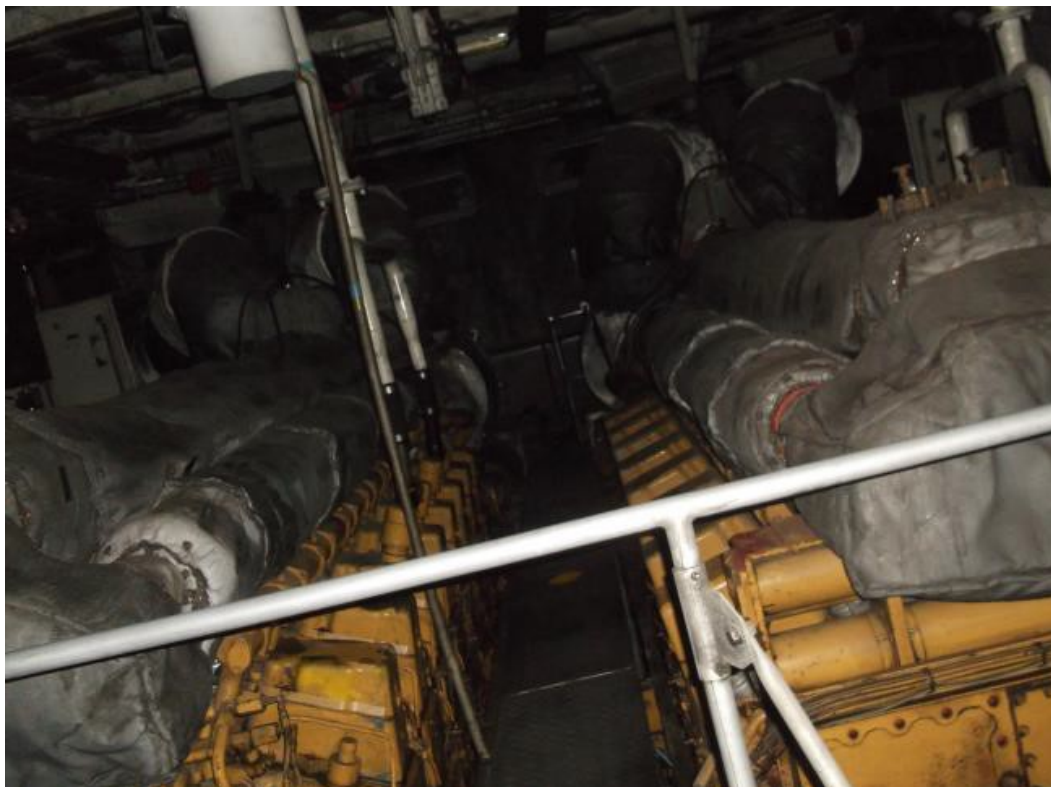
**Inside engine room – (was reported in dry condition)**

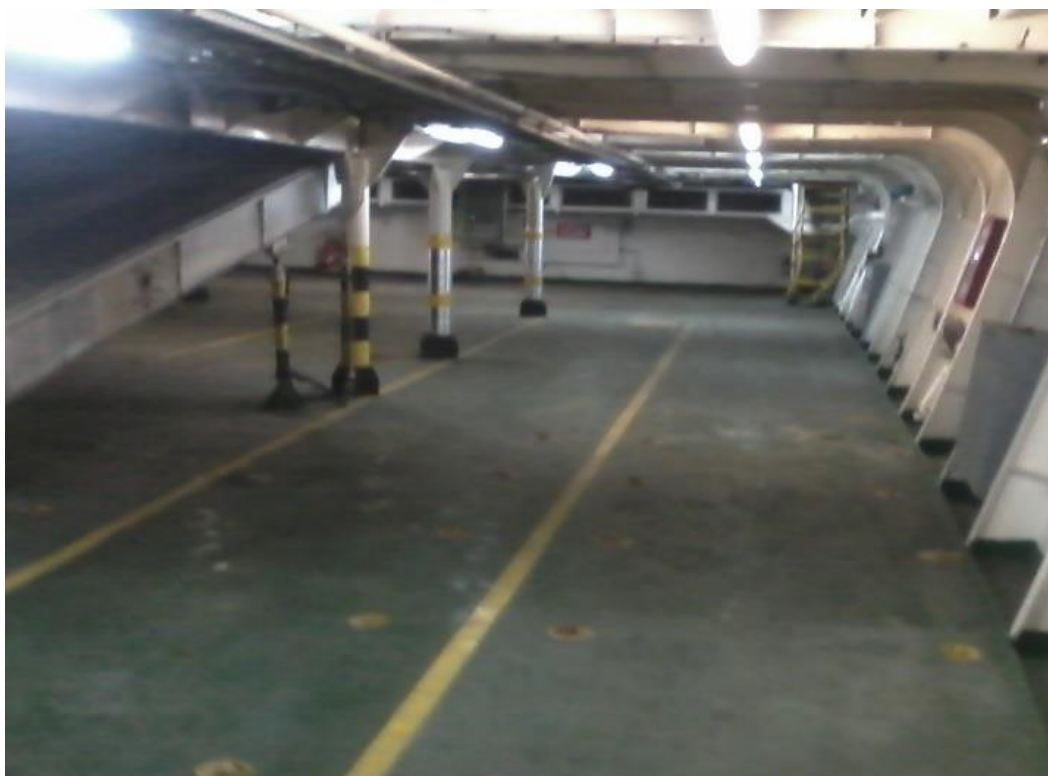
**Vehicles deck– (was reported in dry condition) - Ro-Ro space (garage deck) visual inspection before sailing found it in good condition**

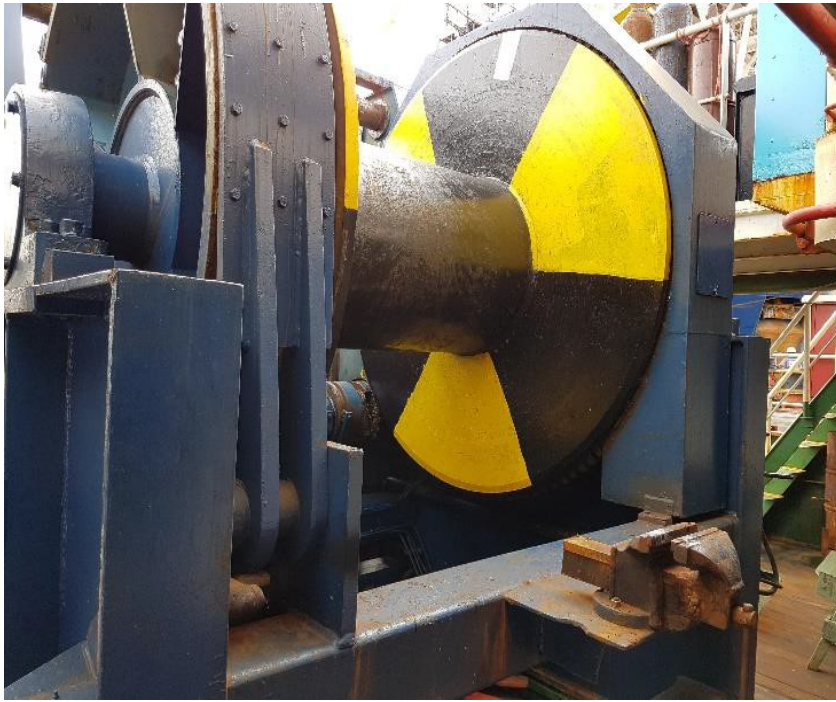
**Tug-Boat “Symphony 14” full length of the primary tow wire was released from the wire clamp during sinking of the HSC “Mykonos Jet”**

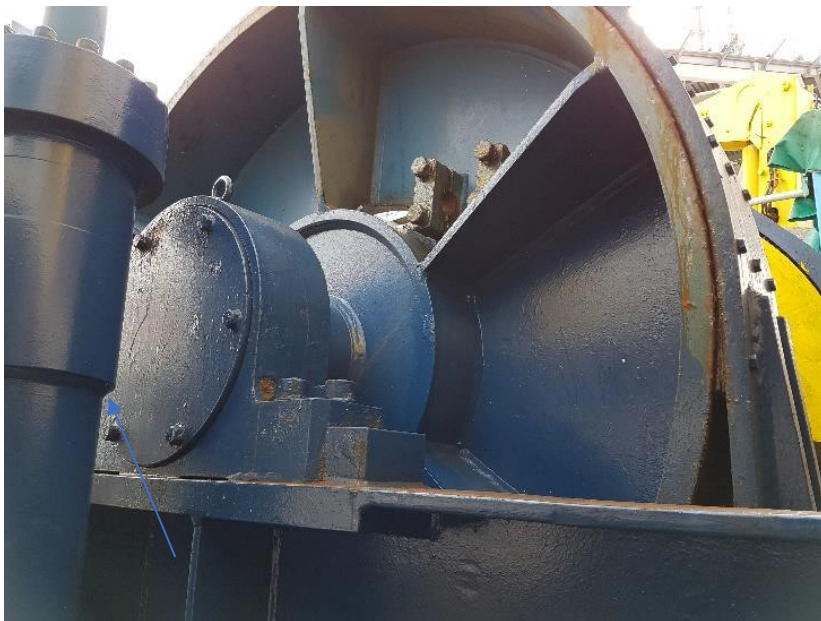
**The Wire clamp of the tow wire which was released during the sinking**

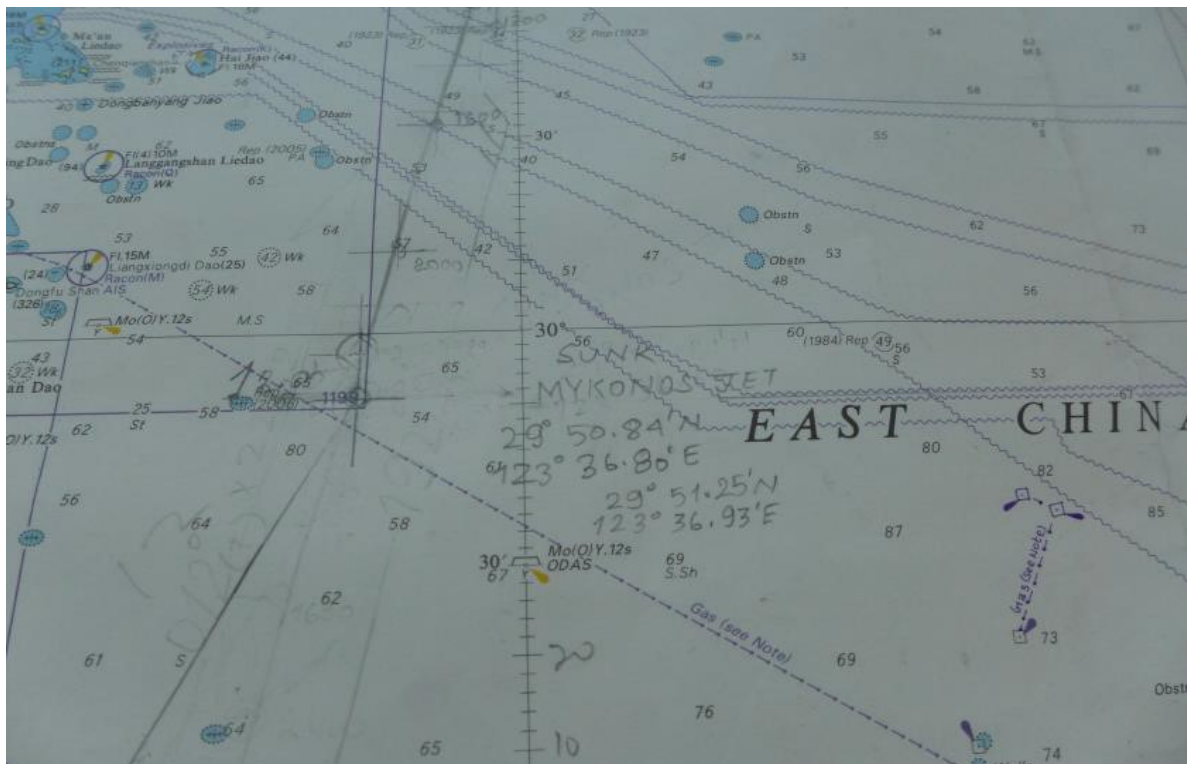
**Chart used on Tug-Boat “Symphony 14” - Location at the time of the incident**
