**The Bahamas
Maritime Authority**

“M.v. Freedom of the Seas”

**Report of the investigation into a casing fire in the
outer approaches to Falmouth, Jamaica on 22nd July
2015**

Date of Issue: 27th February 2017
Bahamas Maritime Authority
120 Old Broad Street
LONDON
EC2N 1AR
United Kingdom

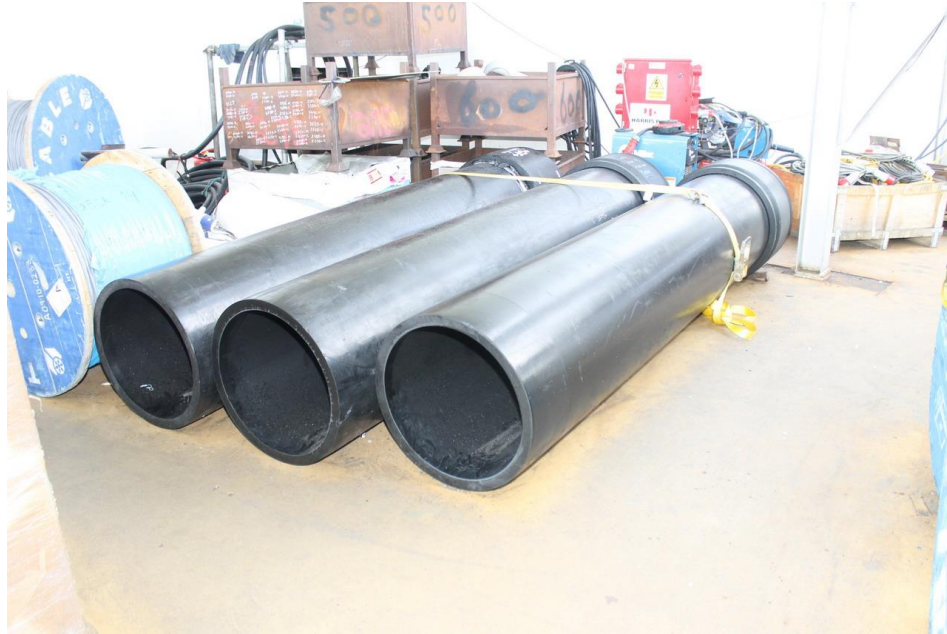
- 4.3 The exhaust for the AEP system included two ducts that would transit the forward port side of the casing. These would consist of two thermoplastic pipes, one at 500mm diameter (DN500) and one at 600mm diameter (DN600), each made up of multiple sections of polyethylene piping fused together and held in place by welded metal brackets.

Figure 6: Ducting awaiting installation

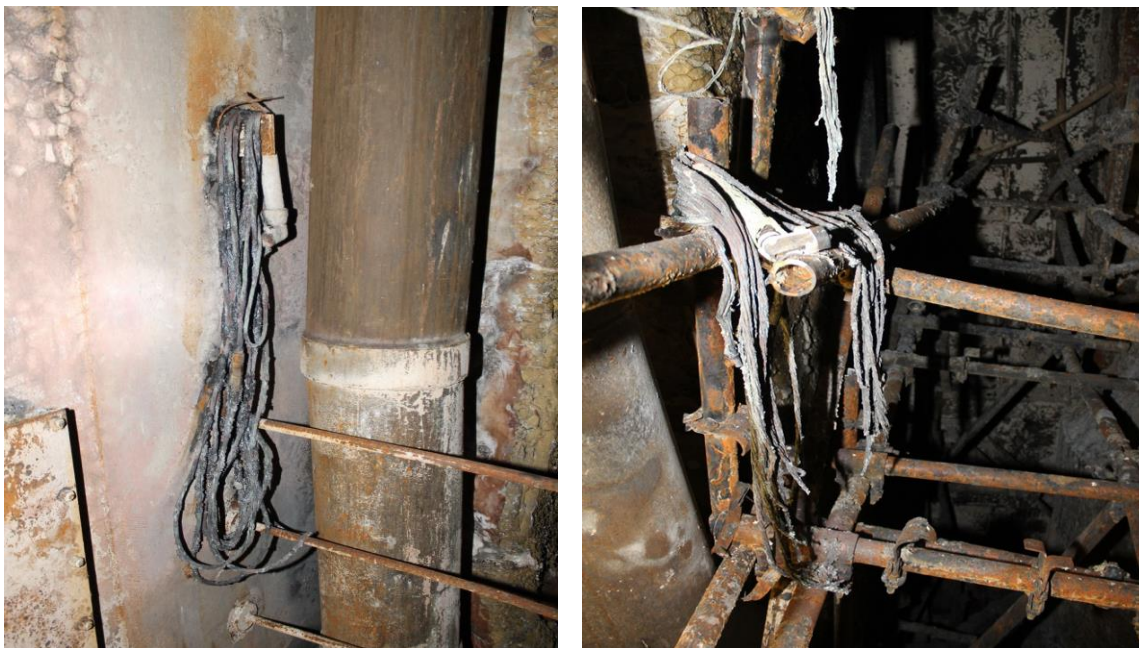
- 4.12 Two plasma-cutting torches used in the casing by contractors were found coiled up and disconnected. There had been no requirement for any use of this equipment preceding the fire.

Figure 9: Plasma cutting torch leads pictured after the fire

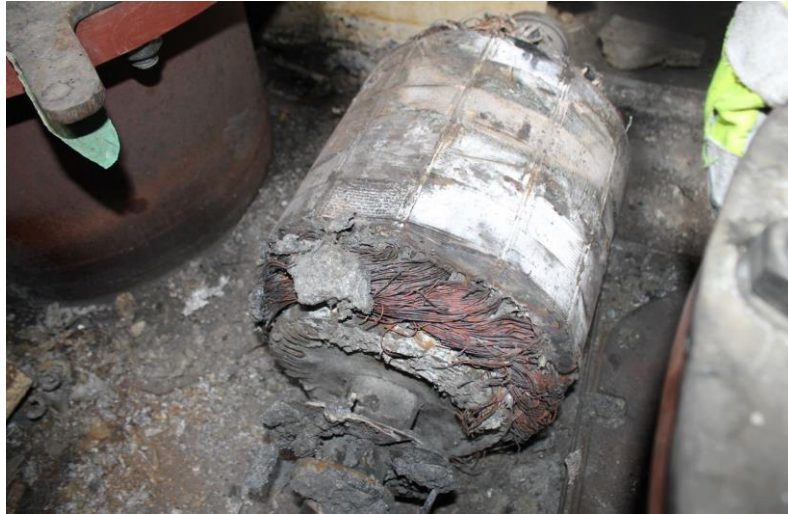
- 4.13 Closed circuit camera (CCTV) recordings were reviewed and contractor's crew were interviewed. The two men on day shift in the casing were verified to have exited the casing approximately 20 minutes prior to the start of the fire.
- 4.14 Fixed electrical equipment within the casing was examined as a potential ignition source. The following were eliminated:
- i An exhaust fan at deck 12. The motor itself, the casing and the electrical connections showed no signs of failure. The fan is protected by a variable frequency drive and a breaker.

Figure 10: Deck 12 exhaust fan motor

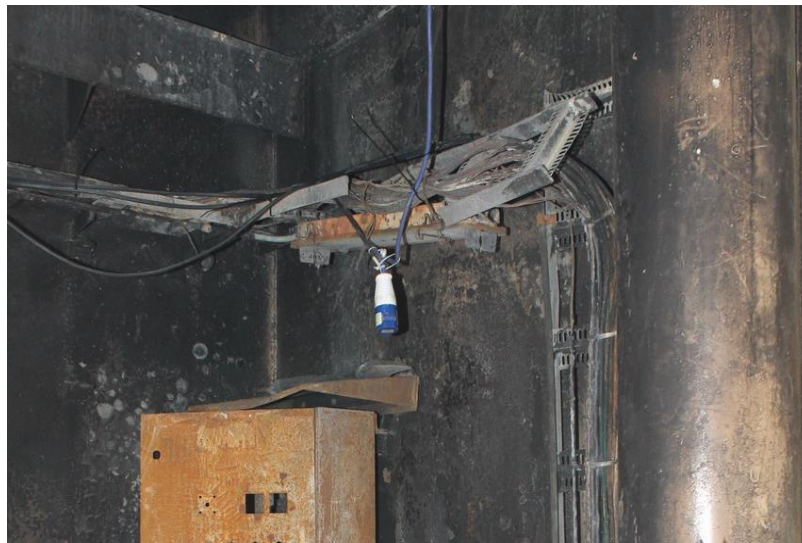
- ii Fluorescent lighting was examined and eliminated as a potential source due to the lack of ability for the light cover to easily ignite.

Figure 11: Florescent light fixture damage

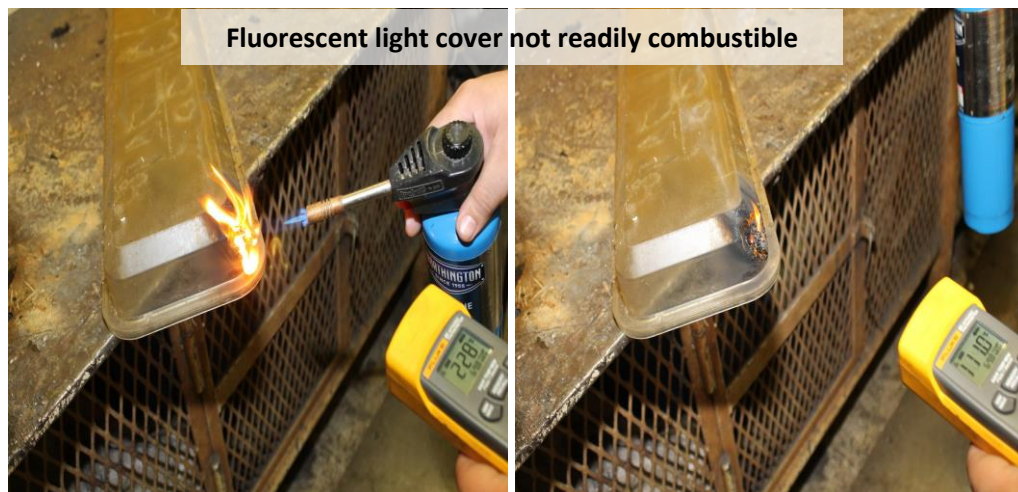
Figure 12: Florescent lighting fire tests

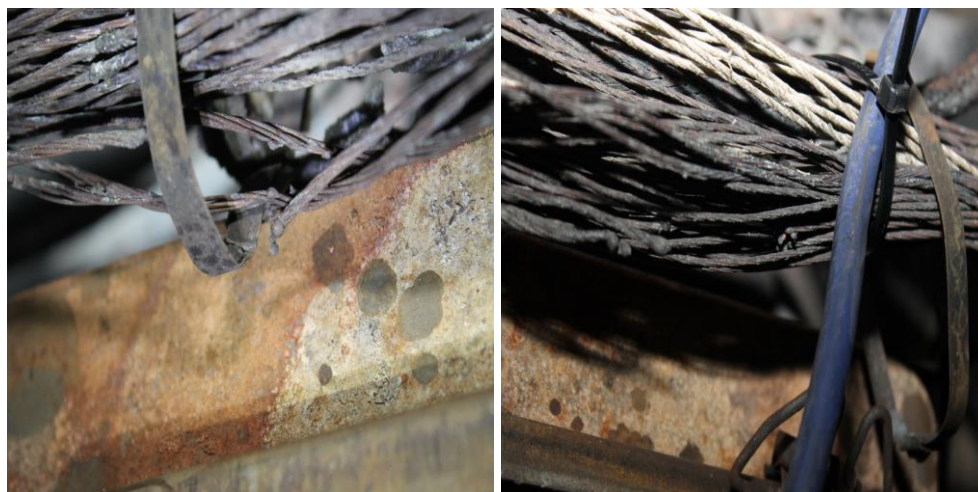
- iii Electrical cabling was examined. Minor arcing was noted in two places. This was eliminated as a source for the fire by the forensic fire expert from Burgoyne.

Figure 13: Electrical cables inside casing

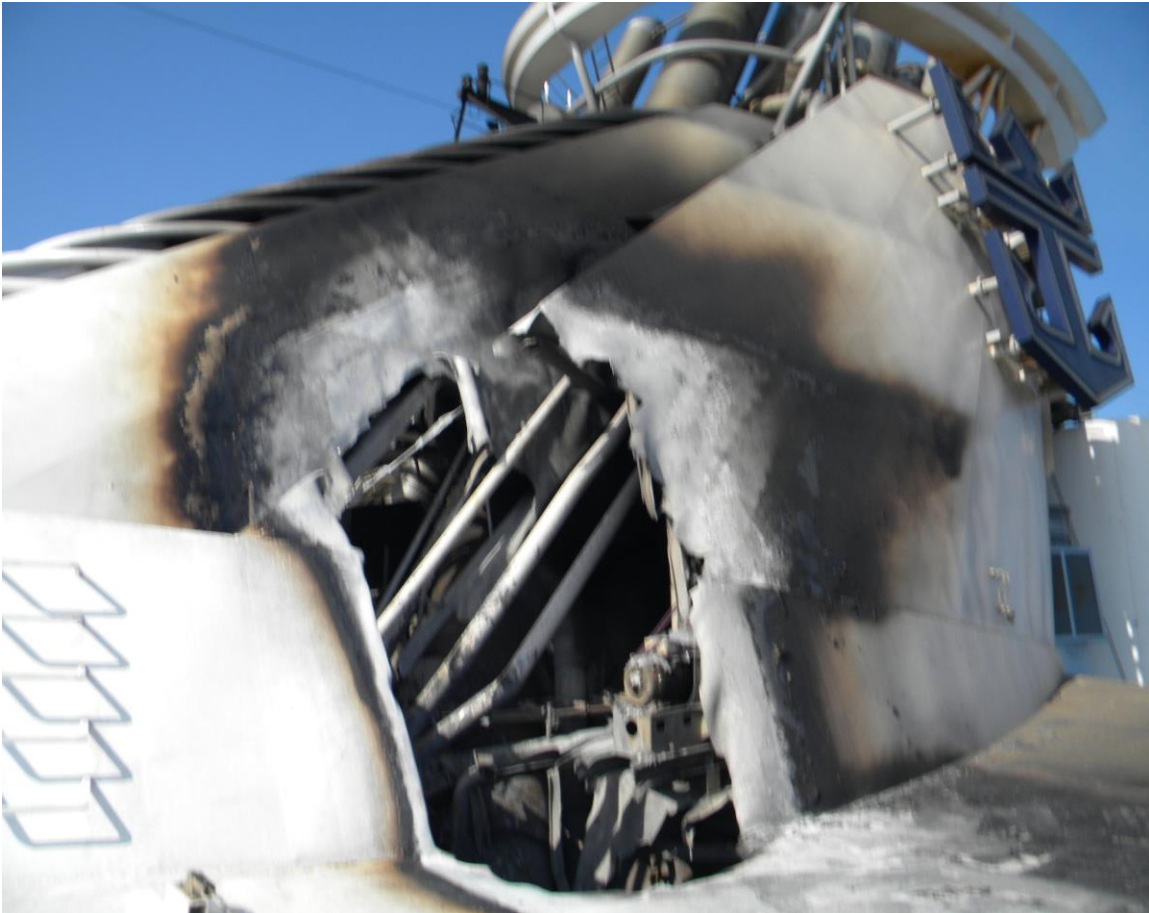
- i Crown deck failure

Figure 16: External damage at the Viking Crown, deck 16

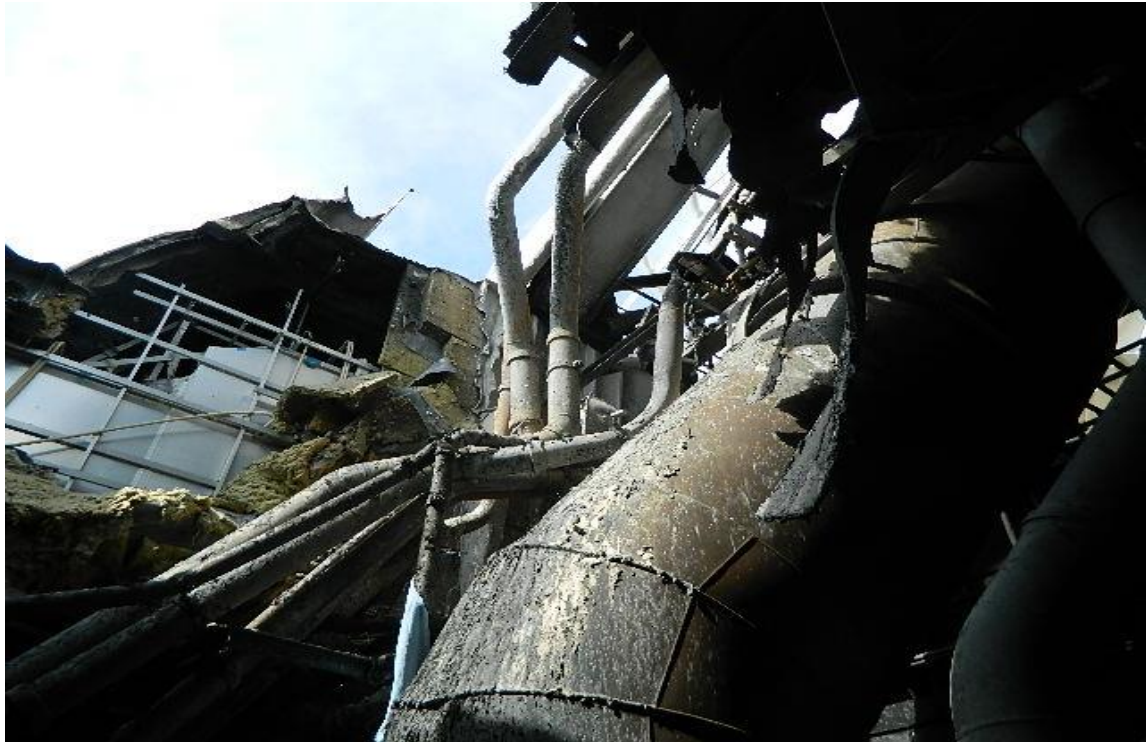
Figure 17: Internal damage at Viking Crown, deck 16. Exhaust duct from generator No.3, pre-heating cooling system, scupper drain lines, exhaust gas line from boilers, safety valves and air conditioning drain lines damaged

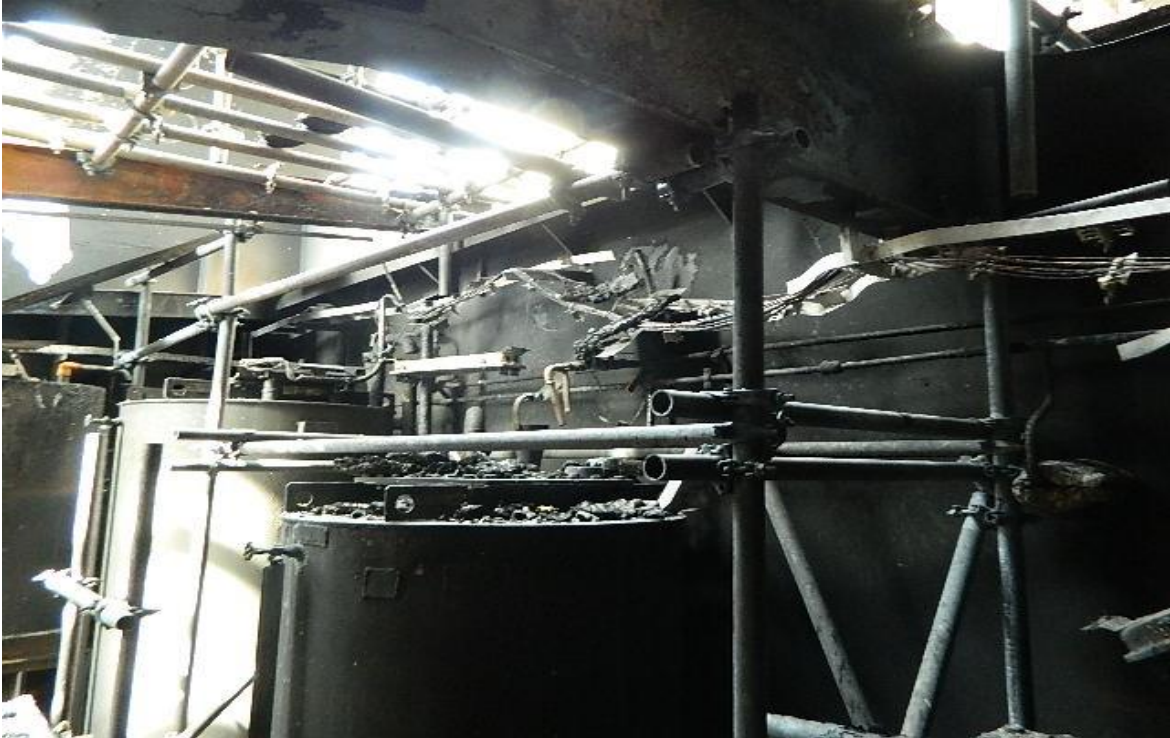
Figure 19: Deck 15 expansion tanks and level indicators

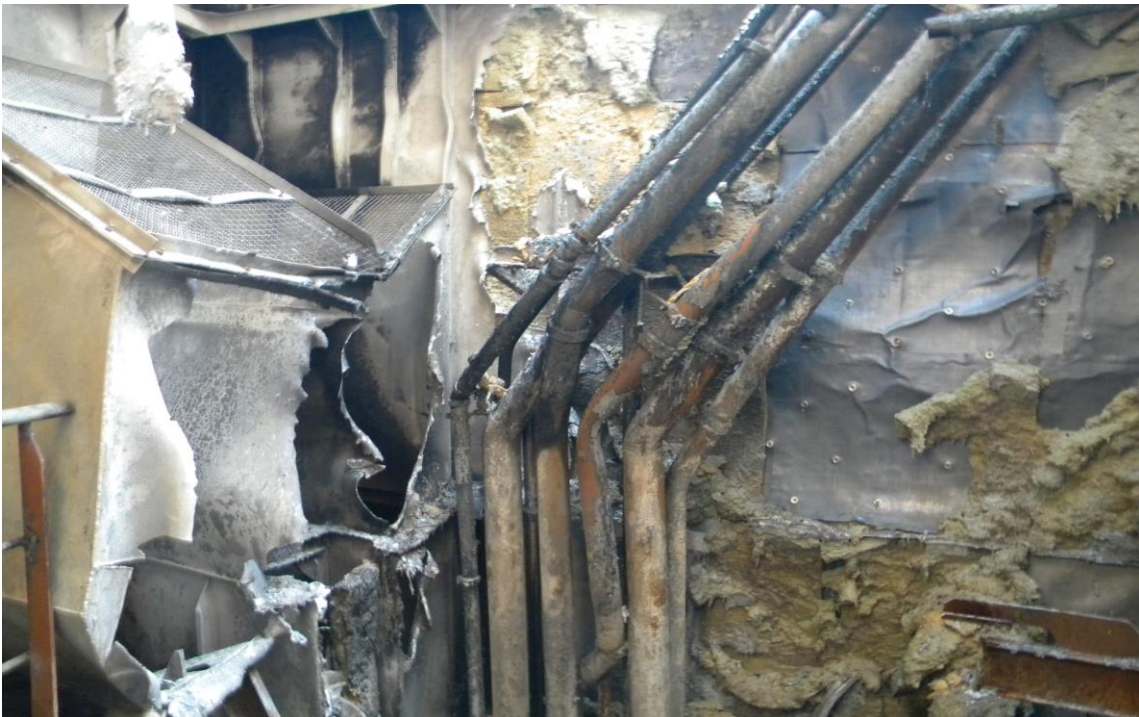
Figure 20: Deck 14 ducting for generator air supply, bioreactor exhaust fan, scupper drains, exhaust gas boiler safety valves, air conditioning system drains and pre-heating cooling system drains

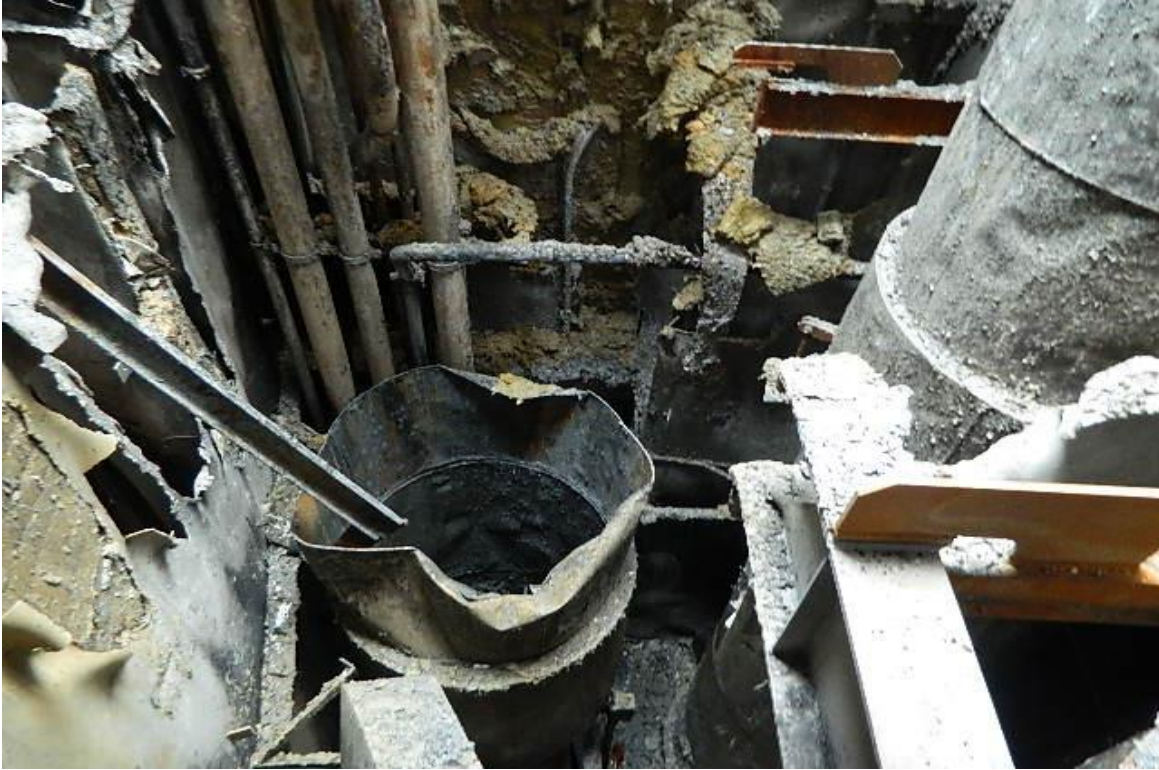
Figure 21: Deck 12, main engine casing exhaust duct

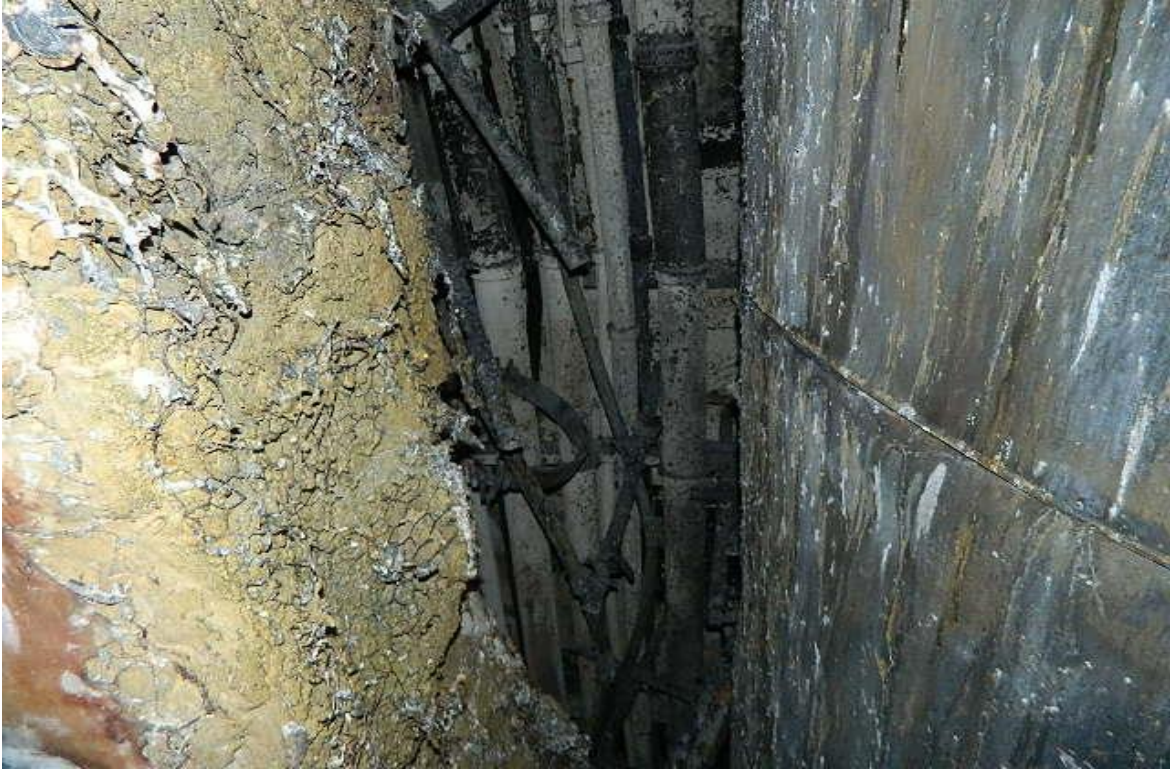
Figure 23: Deck 8, insulation and coating damages

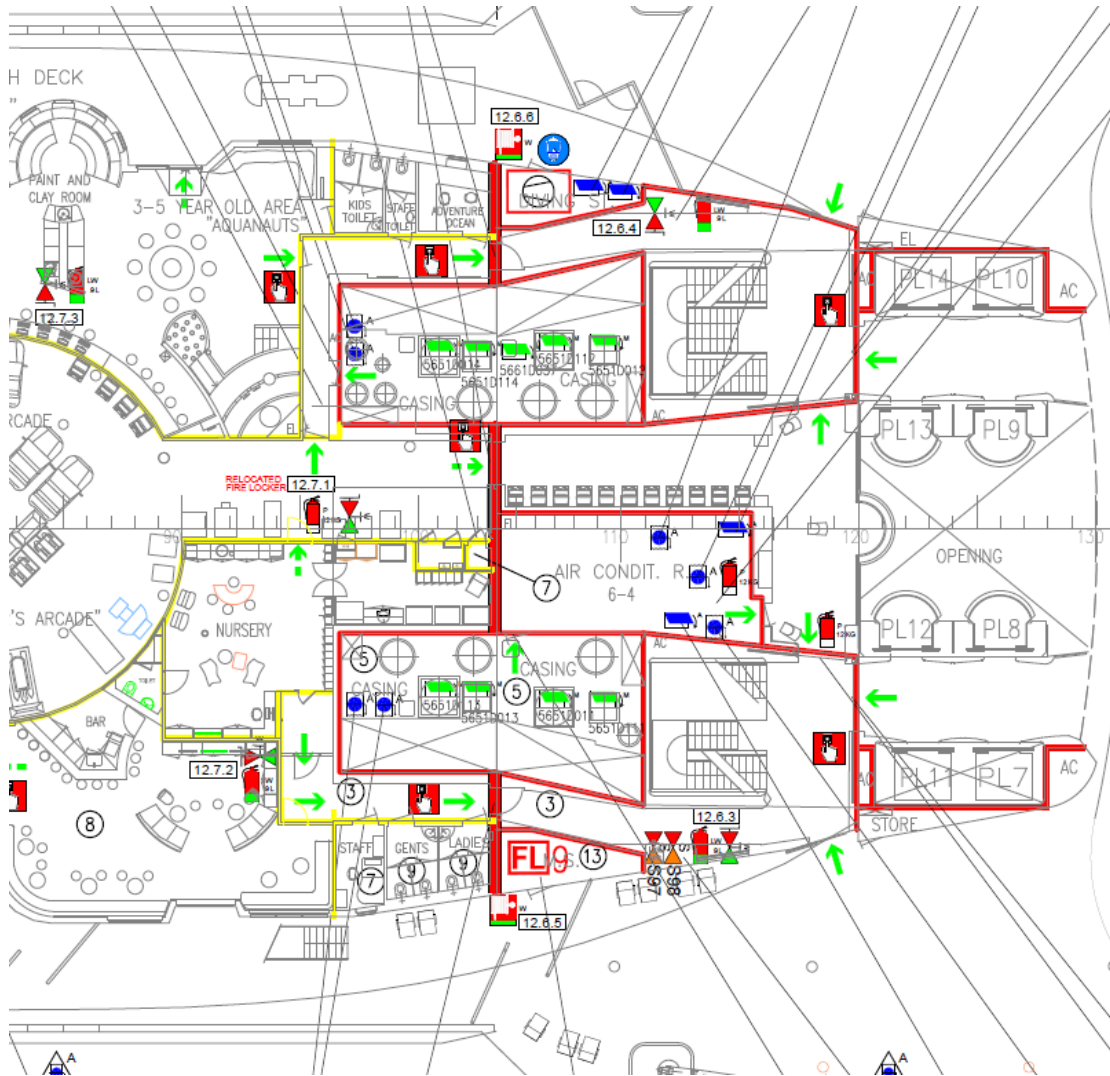
Figure 26: Deck 12

- Structural Damage
- Fire integrity damage
- CO₂ protect. hatch damage
- Exhaust fan Main Engine Room portside - 2 units
- Supply fan for FWD Main Engine room - 2 units
- Exhaust fan from AWP room
- All fire dampers
- Generator room supply fan 2 and also exhaust fan
- Exhaust fan for FWD grey water tanks
- Vacuum interface unit connected to AWP air duct

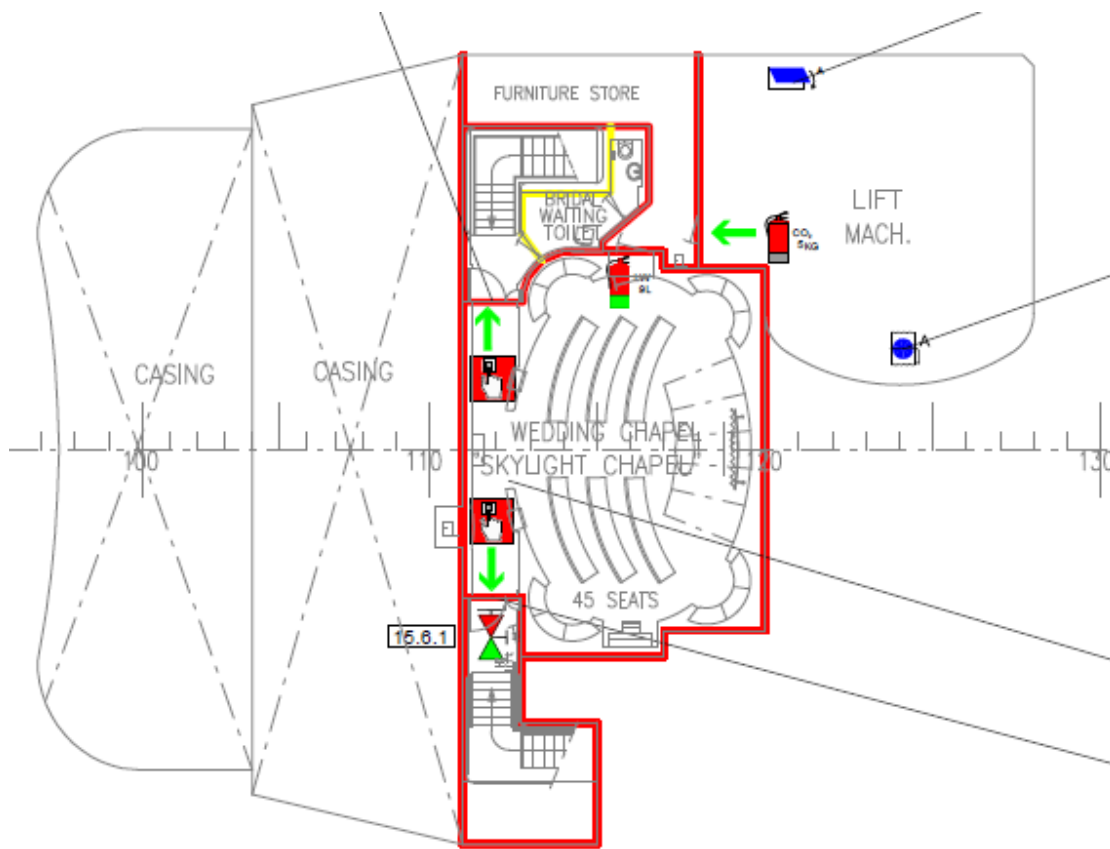
Figure 29: Deck 15

- Structural damage to the casing
- Expansion tanks (preheating, reheating) technical space
- Damaged plumbing and electrical installations - 4 units in total
- Carpet and wallpaper water damage

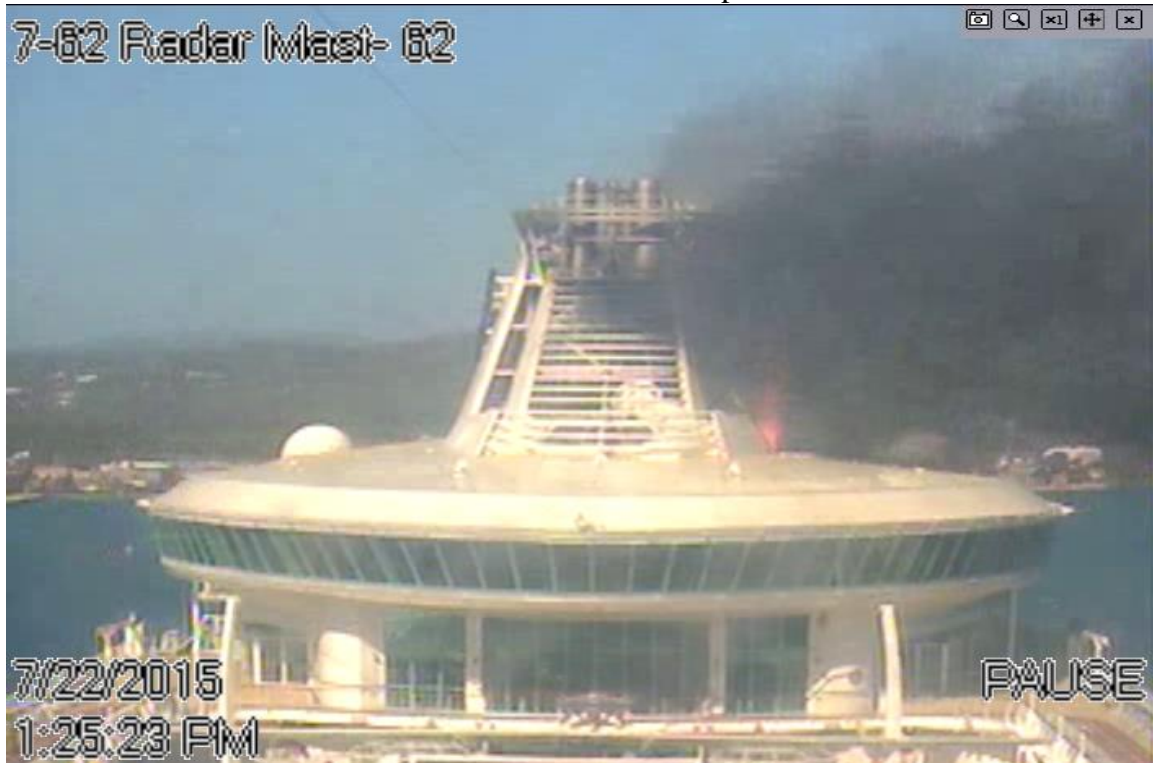
RADAR MAST VIEW AT 09:25 – Smoke and Flames present
