## MARINE SAFETY INVESTIGATION REPORT

Safety investigation into the allision involving the  
Antigua & Barbuda registered heavy-lift

***MARIA***

***ANGELA ARCELLA***

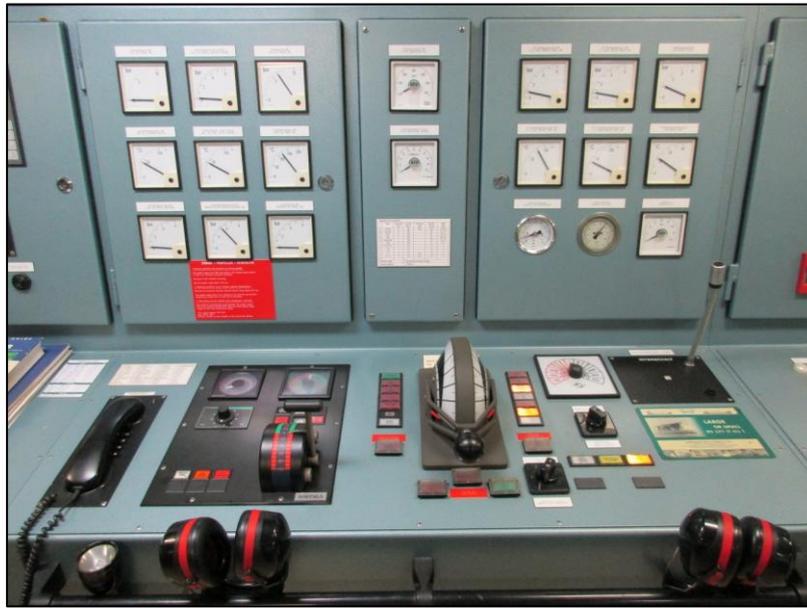
At 1205, an engine control air alarm alerted the chief engineer. He noticed the emergency control of the CPP system activated on the bridge but the pitch indication in the engine control room (ECR) console remained in the ‘0’ position (Figure 11).

**Figure 11: CPP console in the ECR**

<sup>7</sup> The chief engineer reported that the ECR console does not display CPP command given on the bridge.

- .6 The slow but progressive astern running of the propeller was not readily apparent to the master.
- .7 The back-up supply power dropped to zero, resulting in zero pitch feedback which the chief engineer observed in the ECR console.

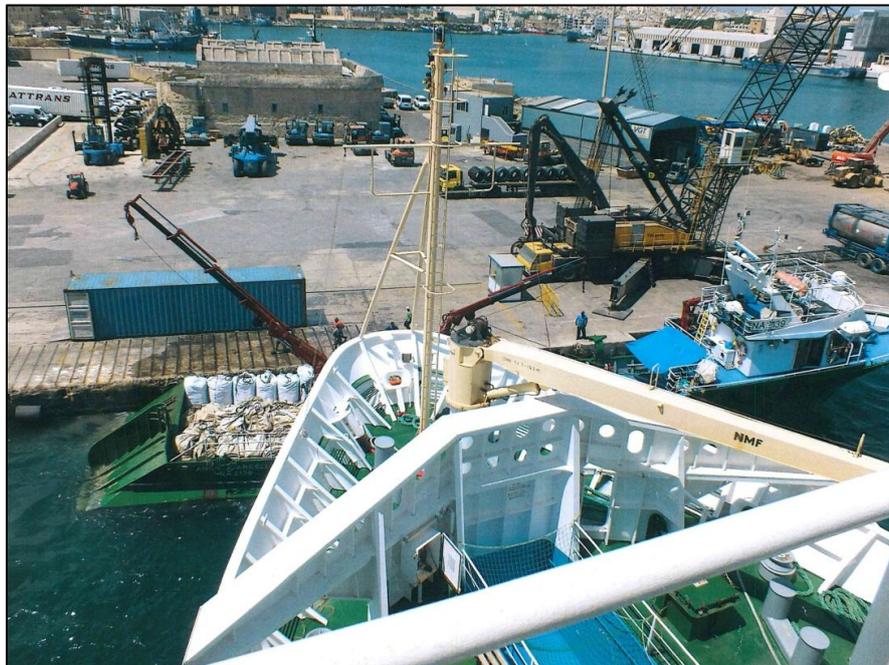
He called the bridge but received no answer. He then rushed out on deck and saw *Maria* slowly moving towards *Angela Arcella*. He hurried back to the engine-room and observed the pitch still in the zero position. The chief engineer then rushed out to check the CPP on the bridge<sup>7</sup>. On his way up, he felt a slight impact. At 1206/14s, *Maria*'s bulbous bow struck *Angela Arcella* (Figure 12).

**Figure 12: Allision with the fishing boat**

The allision with *Angela Arcella* was primarily caused by *Maria* not instantly responding to the master's astern command. The CPP did not develop sufficient power in time to counter the vessel's headway and prevent the bulbous bow from striking the fishing vessel. The controlling effect of dropping anchor, with the bow thruster full to port on the vessel's advance or direction was difficult to estimate.

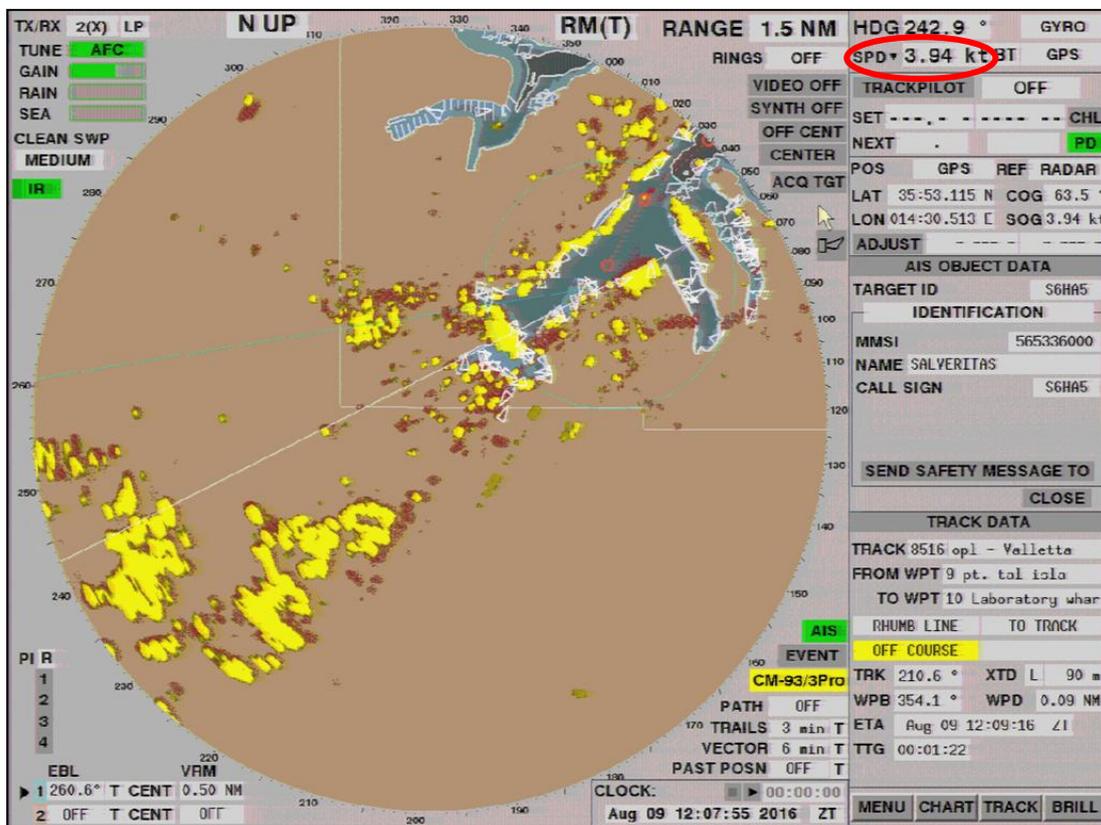
On impact, *Maria* gathered astern momentum. The anchor chain held on to three shackles, became taut, and the vessel veered towards the quay and *Union*. At 1207/55s, *Maria* running astern at about 3.94 knots (Figure 13), struck *Union* and her hull scraped against the quay deck. The mooring ropes parted and *Union* was adrift in the Harbour.

Figure 13: VDR image showing astern speed at 1207/55s

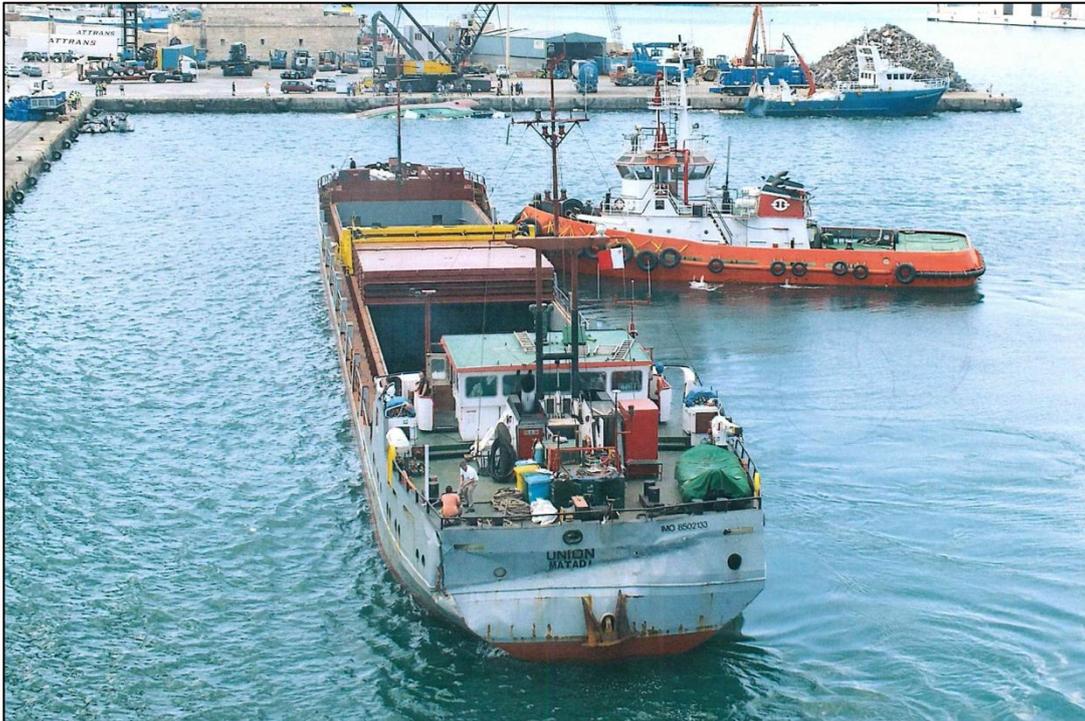
Eventually, a second pilot boarded *Union* and with the assistance of a harbour tug, berthed her at Laboratory Wharf (Figure 14).

**Figure 14: *Union* being pushed back alongside following the allision**

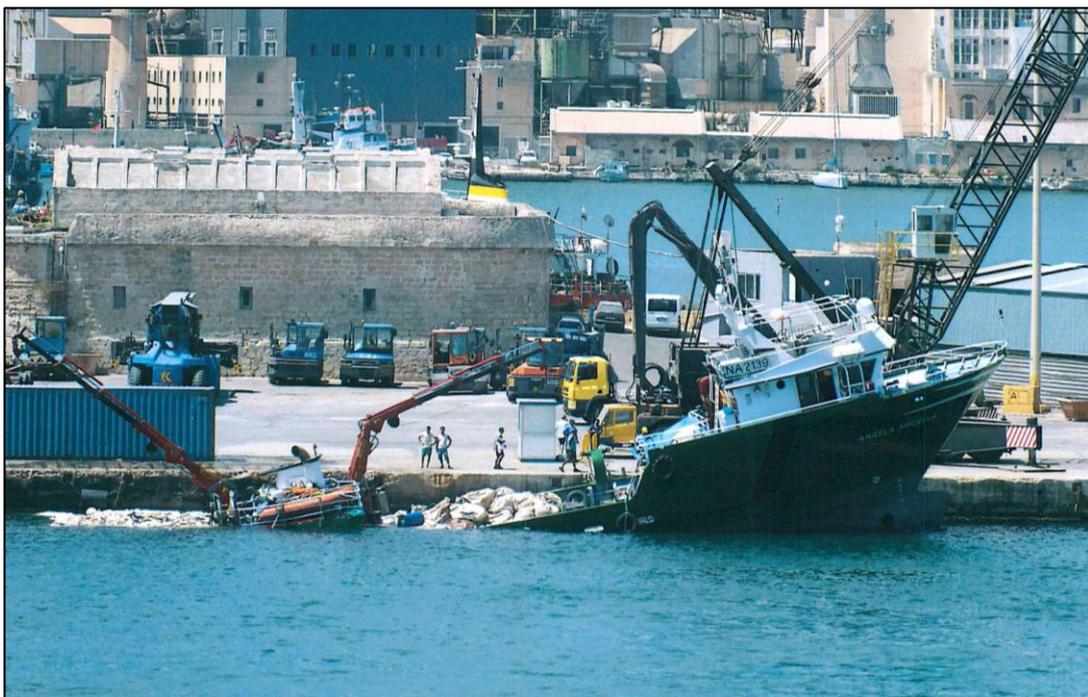
The hull of *Angela Arcella* was pierced below the water line, with consequent massive flooding and loss of reserve buoyancy (Figure 15).

**Figure 15: *Angela Arcella*'s massive flooding and loss of reserve buoyancy**

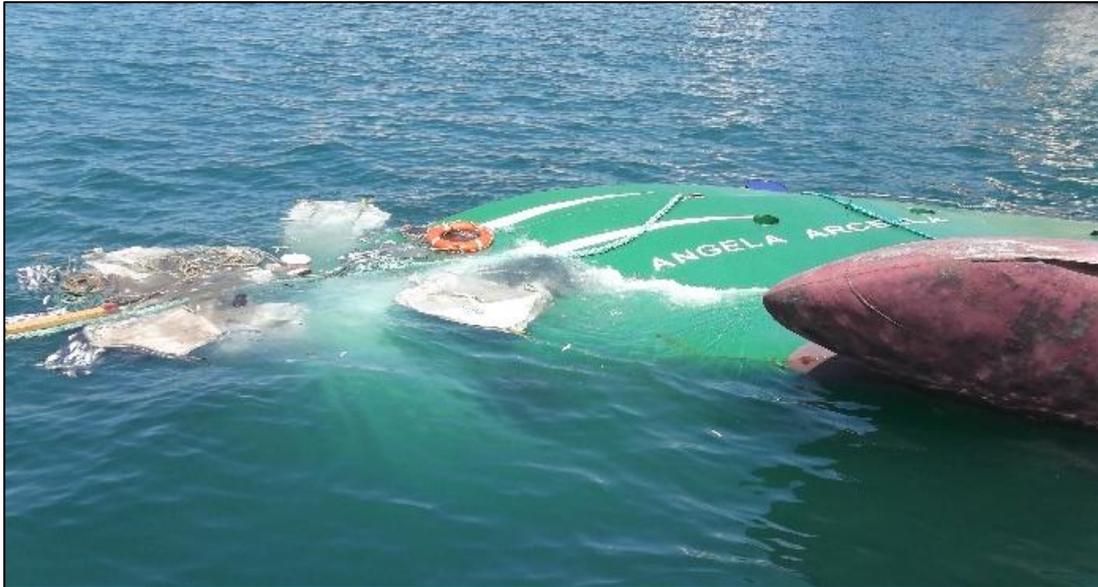
The fishing vessel eventually went down first by her stern and then capsized on her starboard side (Figure 16). Traffic in the port was temporarily suspended.

**Figure 16: FV *Angela Arcella* foundered within minutes of the allision**

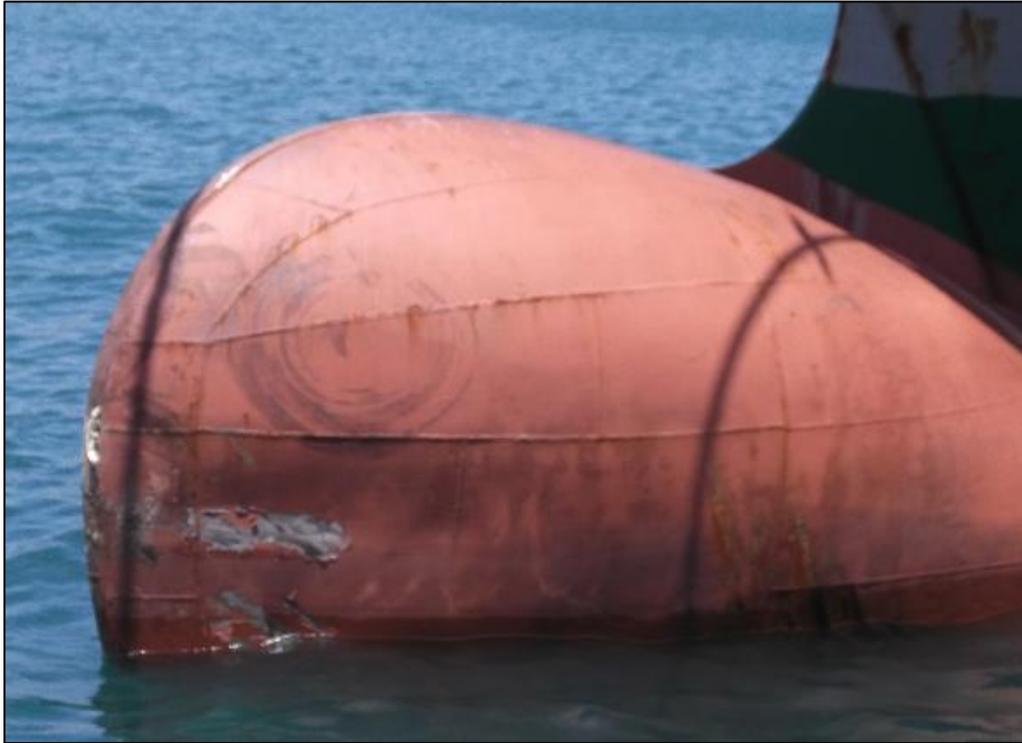
The damage sustained by *Maria* was assessed by the crew. There was no water ingress and initial reports indicated minor indentation on the bulbous bow, scratch marks and slight indentation on her stern and ship side where she struck *Union* and

**Figure 17: Damage to the bulbous bow**

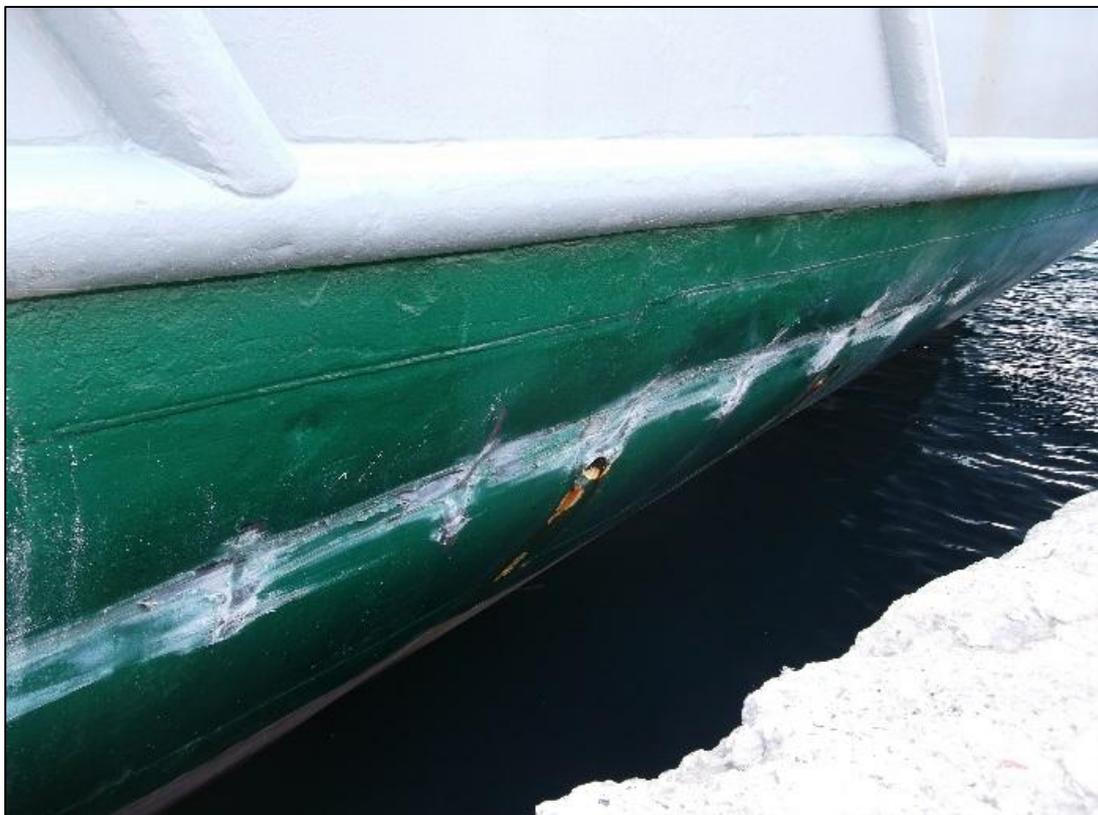
**Figure 18: Ship side damage caused by contact with the quay**

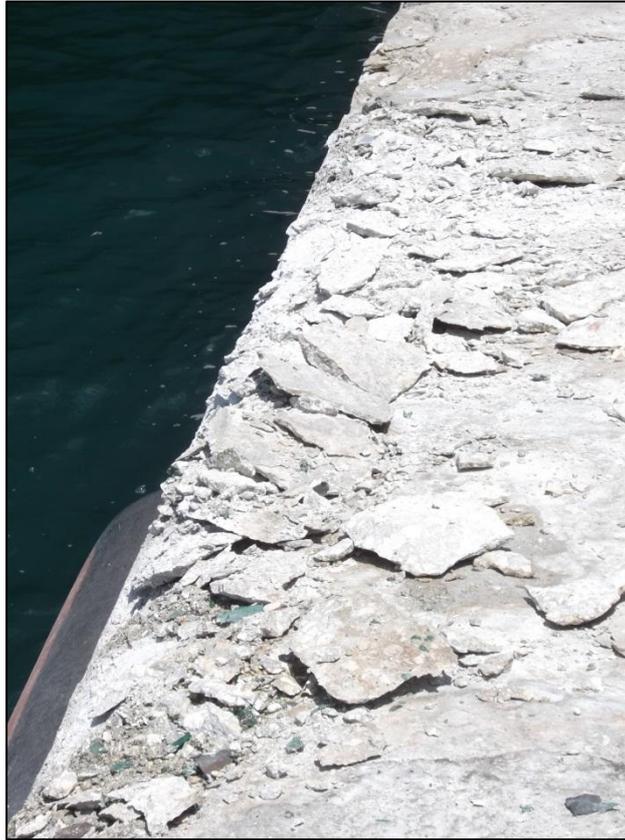
grazed against the quay structure (Figures 17 and 18). There was also damage to the quay (Figure 19).

**Figure 19: Damages to the quay**

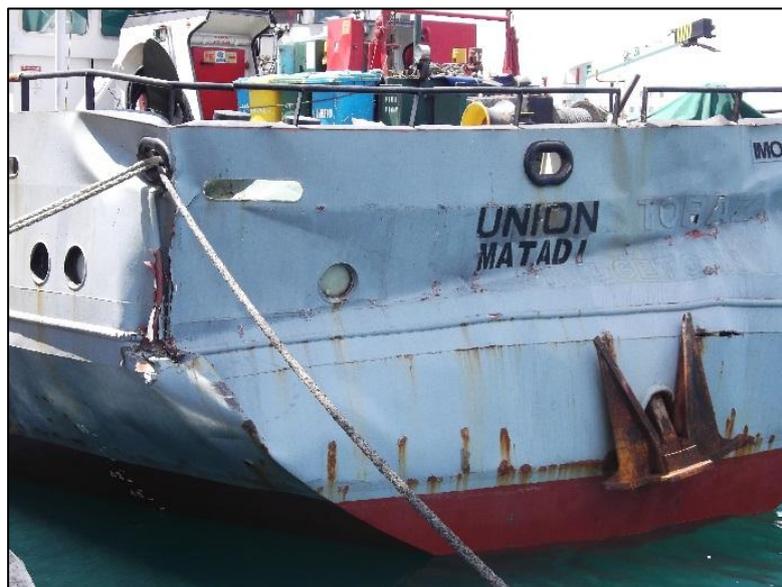
*Union*'s master reported fracture and indentation on the vessel's stern (Figure 20), water ingress in the aft peak tank, and a sheared aft mast which fell into the sea. The chief officer's cabin (Figure 21), galley and refrigeration room were reportedly destroyed.

**Figure 20: External structural damage on *Union***

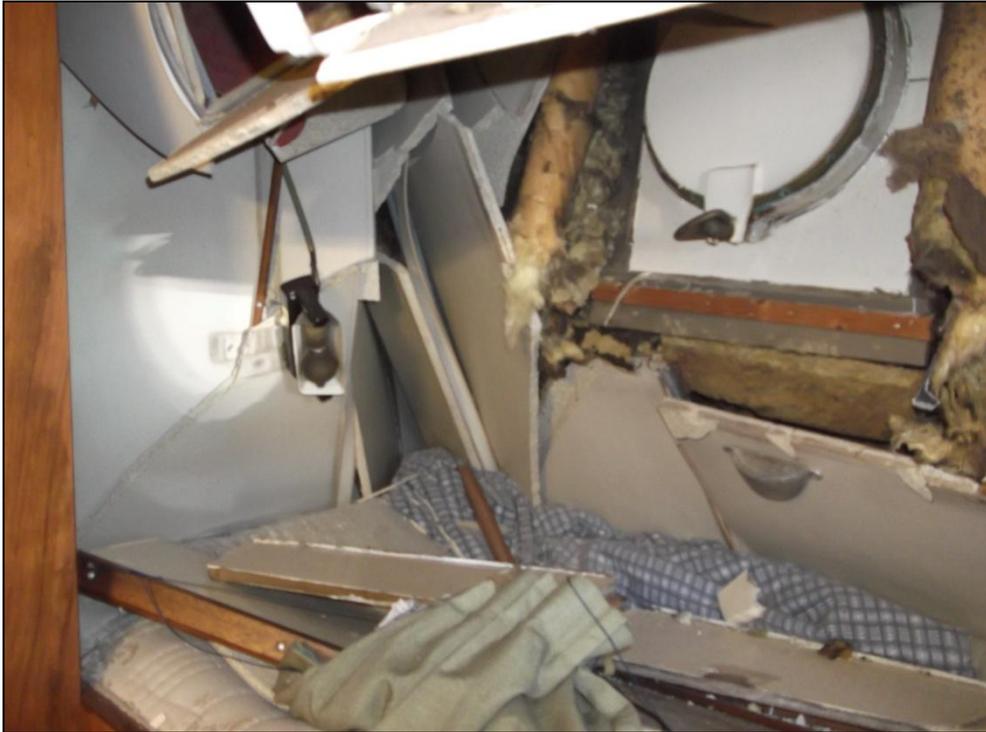
**Figure 21: Internal damages on *Union* (chief mate's cabin)**

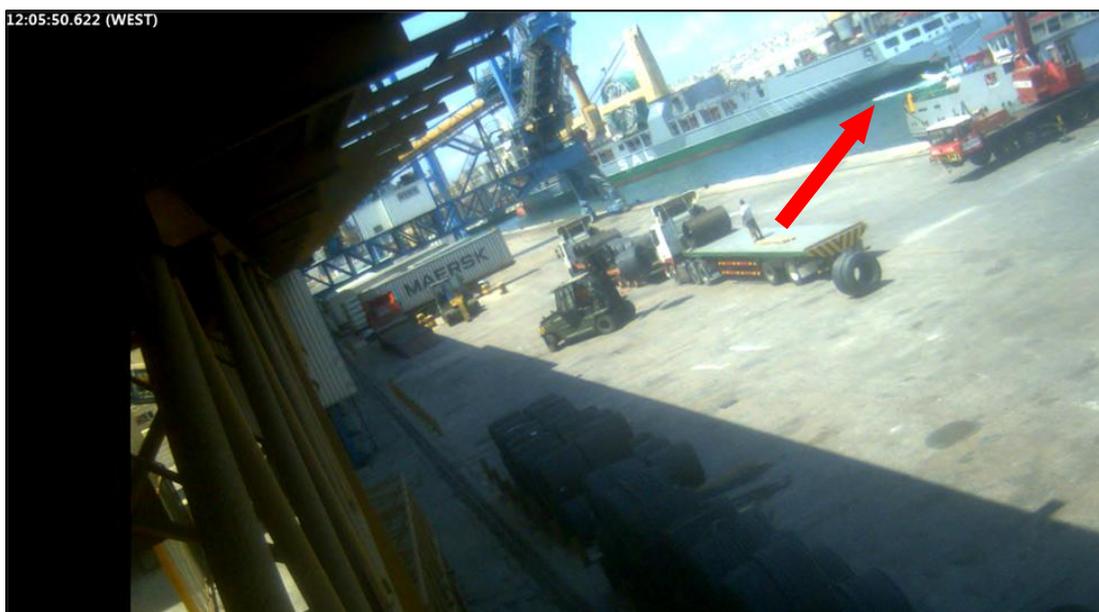
It was very likely that during the brief but critical moments on the bridge, the master, in his efforts to control the ship's headway, pushed the back-up button (off) again and the CPP system reverted back to normal operation. Indeed, the CCTV image (Figure 22) captured at 1205/50s shows a well-defined propeller wash running ahead of the vessel as she passed *Union*, an indication of an astern propulsion in progress, which was more pronounced by 1206/31s (Figure 23).

Figure 22: Image showing astern wash at 1205/50s captured by CCTV

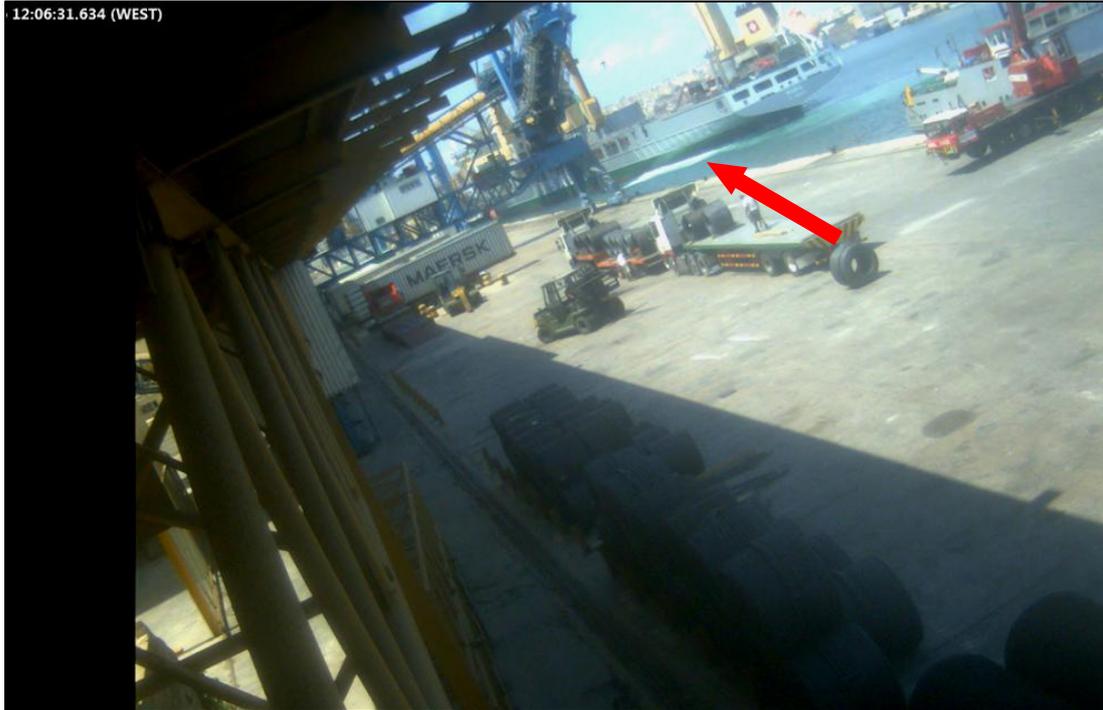
Figure 23: Image of astern wash captured by CCTV at 1206/31s.
