PRELIMINARY INVESTIGATION
REPORT ON THE
SINKING OF
M/V AL SALAM BOCCACCIO 98

August 17, 2006

Panama Maritime Authority
General Directorate of Merchant Marine
Casualty Investigation Branch

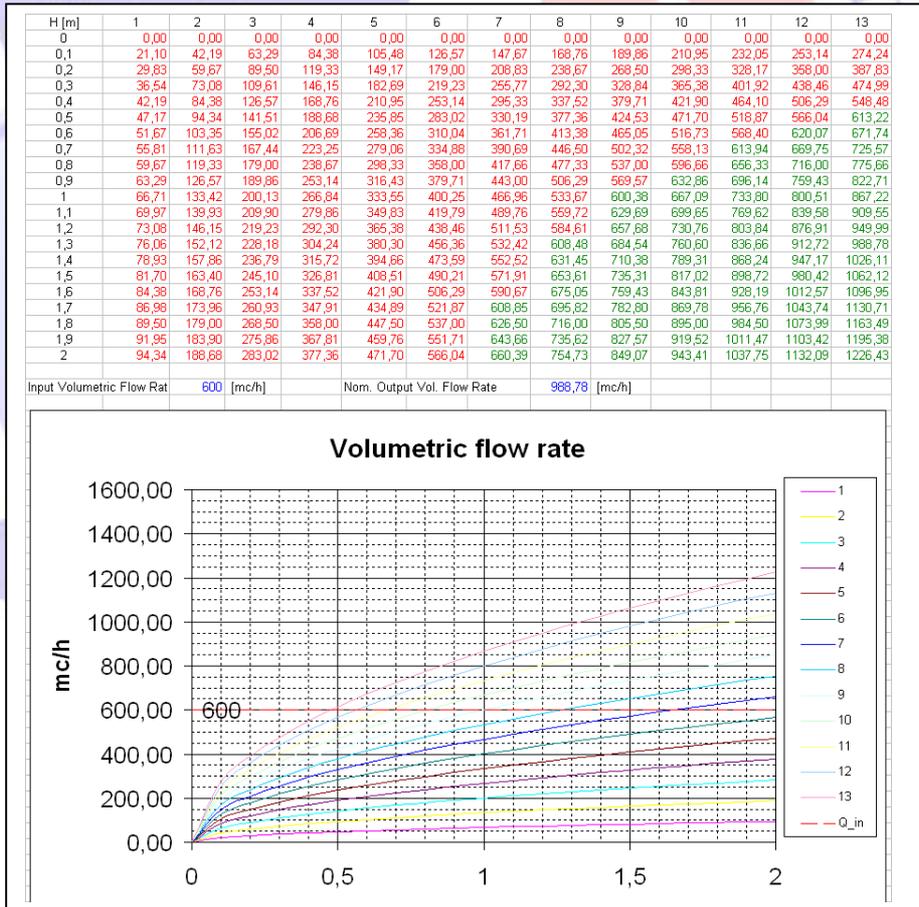
The results are summarized in the following Table, where the output flow rate is calculated for a finite set of total hydrostatic head values (in columns) and number of scuppers (in rows). A value of input flow rate of 600 [m³/h] is assumed. The combinations H / number of scuppers that are sufficient to discharge the input flow rate are printed in green while those that are not sufficient are printed in red. The same results are shown in a graphical form with the volumetric flow rate as a function of the total hydrostatic head and the number of active scuppers as a parameter.

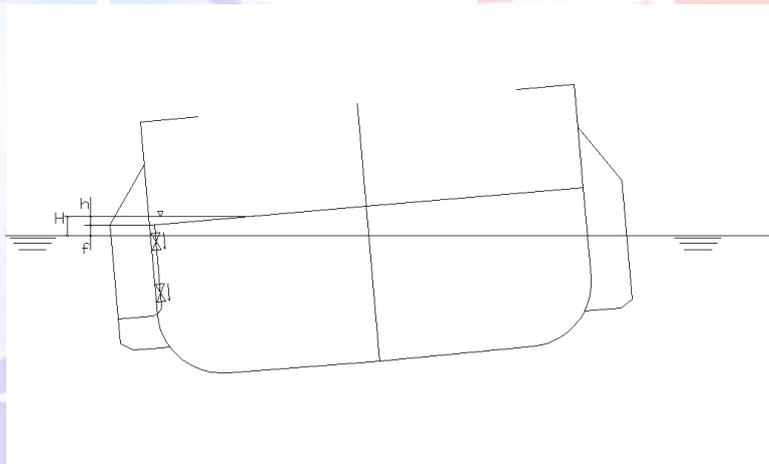
Fig B.2

In this differential equation, the difficult term to evaluate is the one that expresses the total hydrostatic head (H) as a function of the accumulated water on the deck. H depends directly from the current draught, heel angle of the ship, and internal head of water on the deck (h). All these parameters are related to the accumulated mass M . The ship “system” is thus heavily involved in this modelling process.

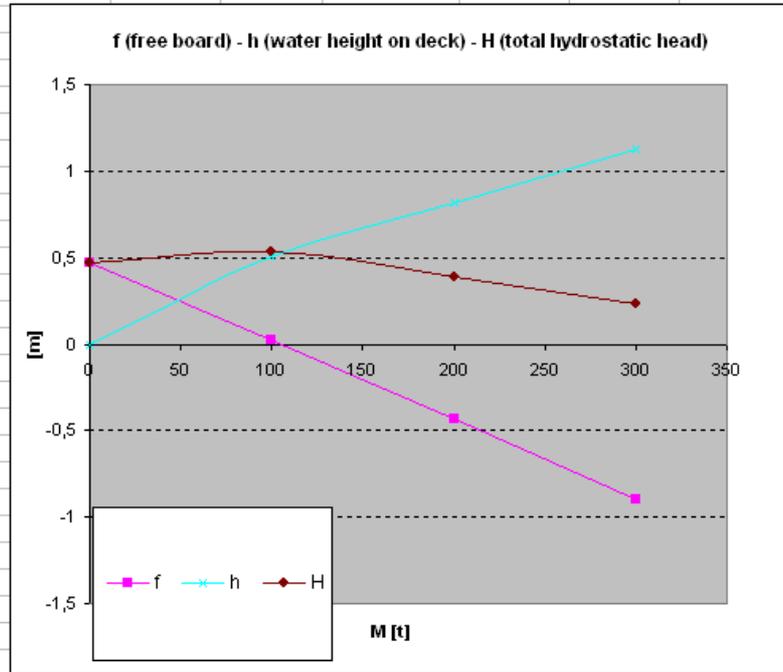
From SIKOB calculations with initial heel angle = 5° Critical Mass = 300 t

Displacement [t]	T [m]	M [t]	Heel angle [°]	f [m]	h [m]	H [m]
9622	5,85	0	5,05	0,47	0	0,47
9722	5,892	100	7,35	0,02	0,51	0,53
9822	5,934	200	9,68	-0,43	0,82	0,39
9922	5,976	300	11,93	-0,9	1,13	0,23
