## MARINE SAFETY INVESTIGATION REPORT

Safety investigation into the allision involving the  
Antigua & Barbuda registered heavy-lift

***MARIA***

***ANGELA ARCELLA***

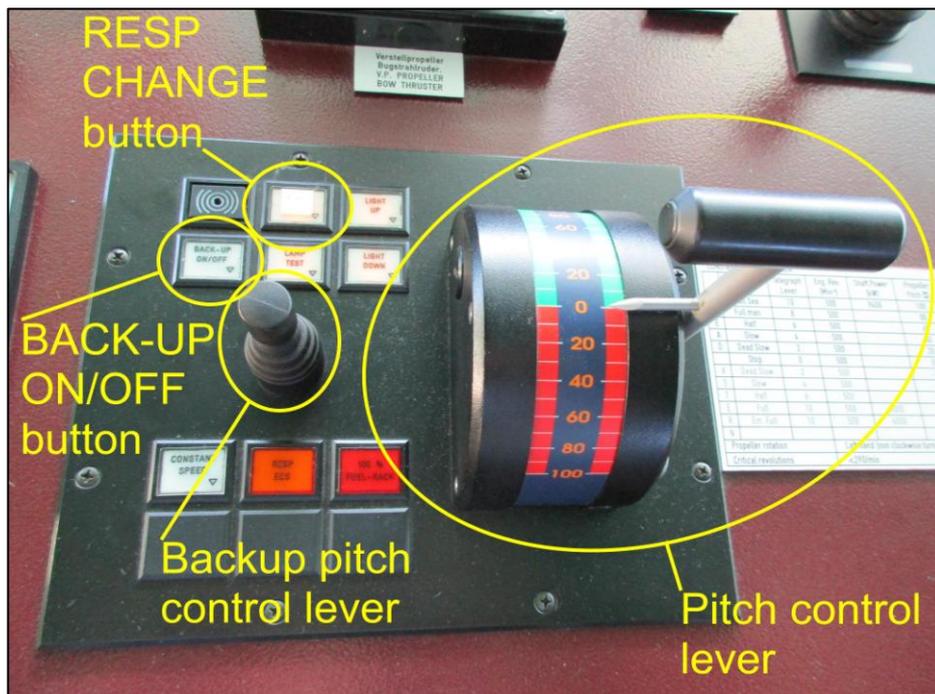
Figure 10: Wheelhouse console showing CPP controls

The pilot reported that at the time her stern was roughly in line between bollards 10 and 11. The master pressed the CPP transfer button and set the pitch control lever astern. He stated that at the time, he could feel<sup>6</sup> the controls not responding to the astern command and the vessel kept going forward. He rushed back inside the bridge to regain control from the main console (Figure 10). He set the pitch control lever astern with no response. Seeing this, he pushed the emergency back-up button and on the emergency back-up he gave the command to go astern. Notwithstanding this, the vessel kept making headway.

The safety investigation noted that no system failure alarms (audible or visual) were detected or reported by the bridge team. During the course of the safety investigation, the MSIU was informed that post allision examination and tests, carried out when the vessel was safely moored alongside, no malfunctioning of the normal operation of the CPP system was identified by the crew.
